***The City of New York
Office of the Comptroller
Bureau of Financial Audit***

**Audit Report on the
Metropolitan Transportation Authority's
Maintenance of Long Island Rail Road Stations
Within the City**

FN01-190A

February 20, 2002

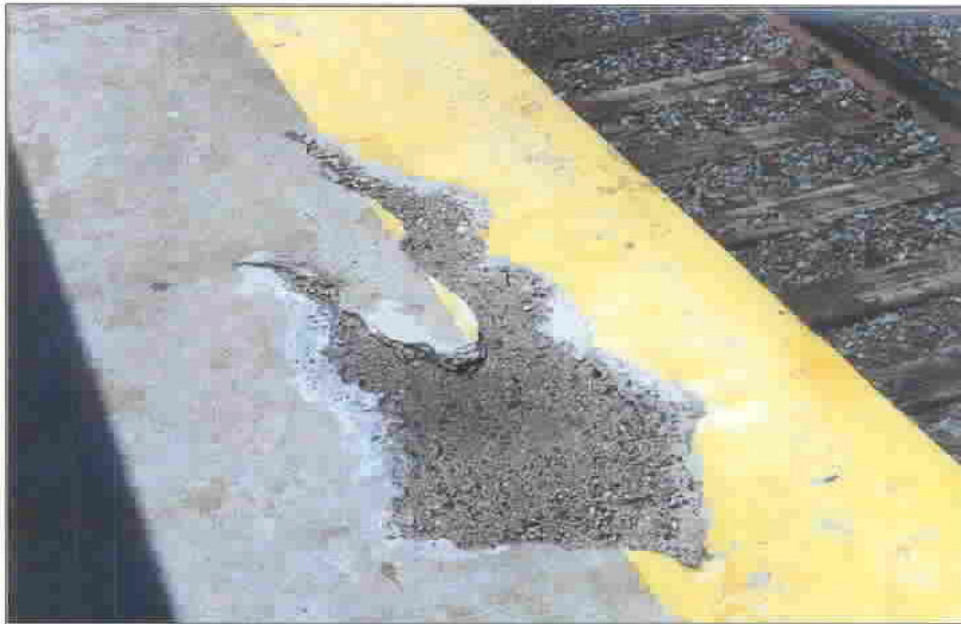
Plexiglas and a metal frame were missing from the westbound shelter. Broken glass was on the front of the eastbound staircase. The eastbound platform had broken concrete. (See photograph on page 1 of Appendix II.) Paint was peeling from the walls of the passenger walkway tunnel. There was graffiti on the westbound platform shelter.

BROADWAY – Broken concrete on the eastbound platform. Observed: July 2, 2001

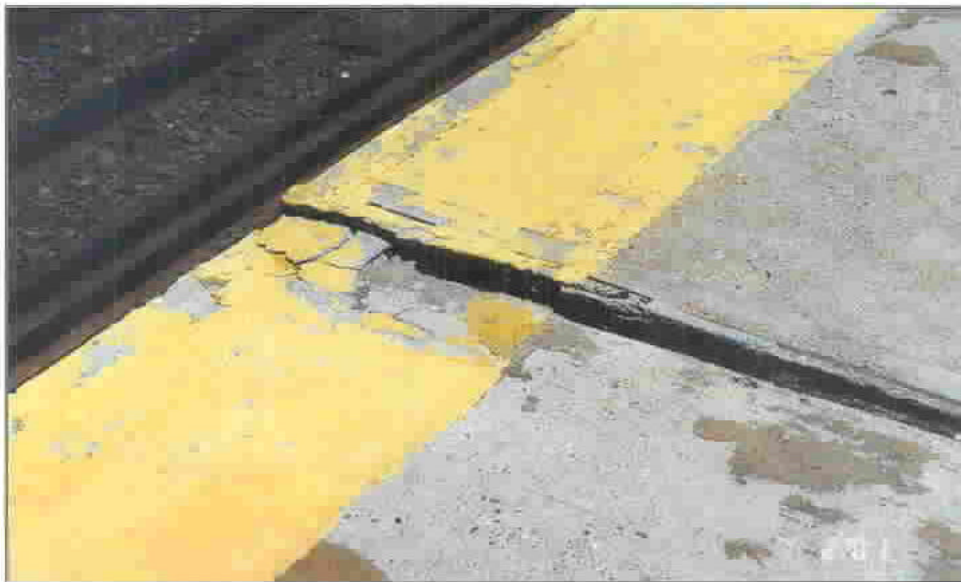
Partially corrected. The loose metal plate on the westbound platform was repaired. The exposed metal rods on the handrail were removed. The loose concrete on the eastbound staircase was repaired. While there was some evidence of concrete patchwork, many areas of the platform were still not repaired. (See photograph on page 2 in Appendix II.) All other conditions remained. The westbound staircase wall still had peeling paint. Although the litter was removed, the station's platform shelter still had dirty benches and walls, and there were uneven sidewalks with pavement gaps on both the westbound and eastbound platforms. (See photographs on pages 1 and 2 in Appendix II.)

BROADWAY – A large gap on the eastbound platform. Condition existed last year. Observed: July 2, 2001

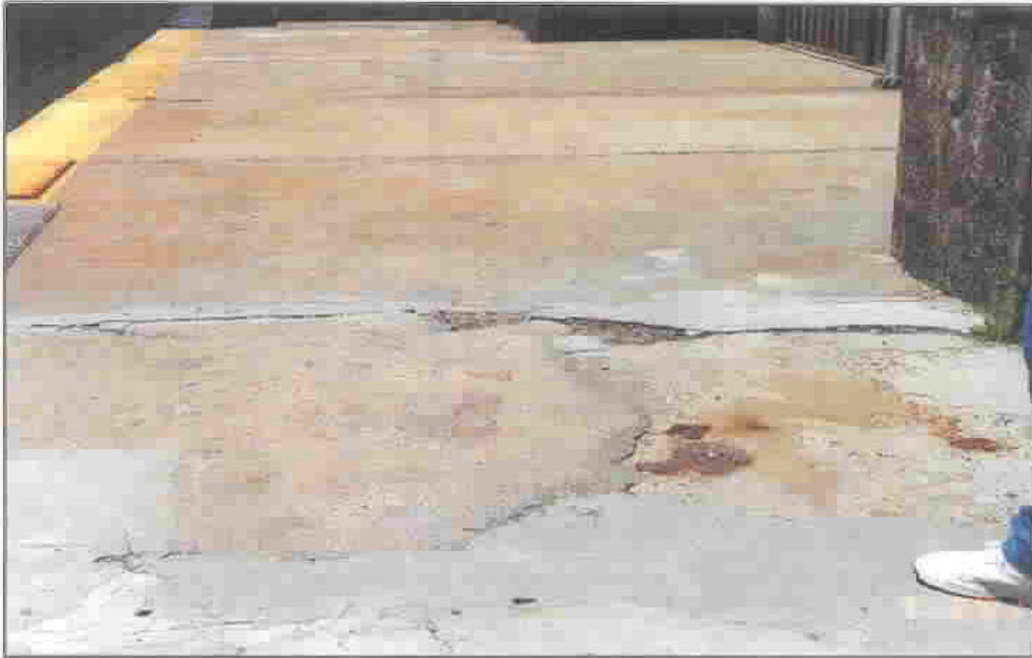
- The LIRR Engineering Department inspected the Broadway Station in October 1998 and in October 2000, and the LIRR Passenger Services Department inspected the station in June 2001. The inspection reports prepared by LIRR disclosed that the station's concrete platforms were cracked and needed to be repaired. Nevertheless, during our inspections in August 2001, we noted that the concrete platform was cracked, which posed a tripping hazard at this station. (See photographs on pages 1 and 2 of Appendix II.)

BROADWAY – Broken and loose concrete on the westbound platform. Condition existed last year.
Observed: July 2, 2001

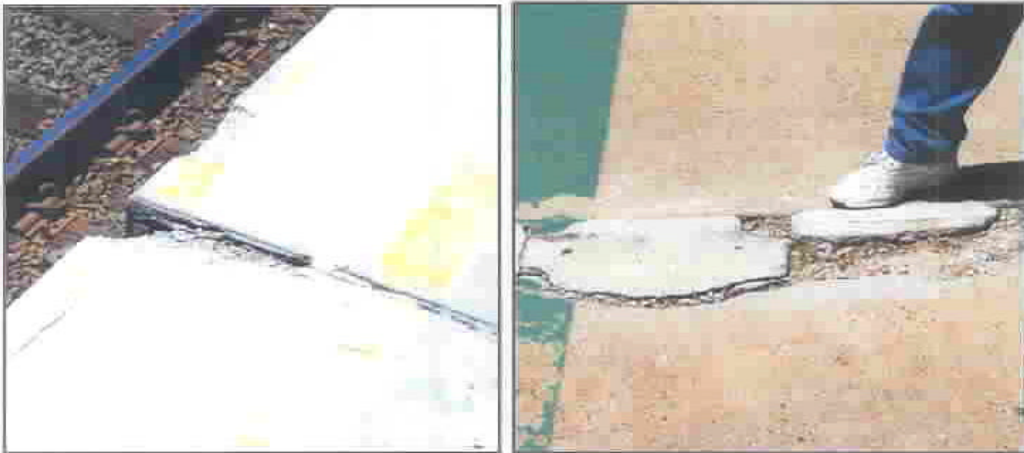
BROADWAY – Broken edge on the westbound platform. (Left). Observed: July 2, 2001
Loose and broken concrete on the westbound platform. (Right). Observed: July 2, 2001

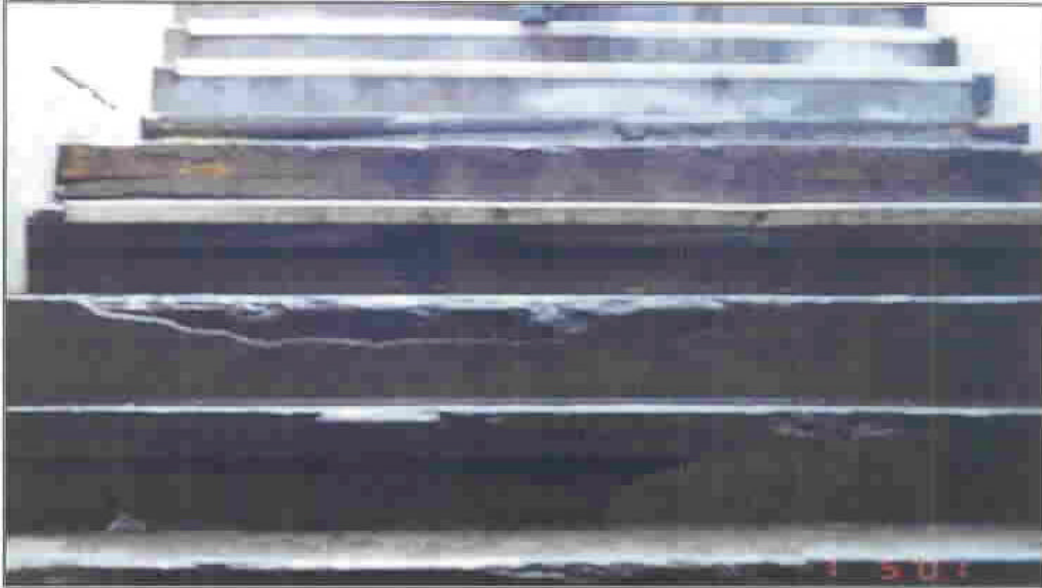
Partially corrected. The cracked cement with a large hole on the eastbound platform was repaired and the litter was removed. Approximately half of the steps on the Van Sinderen Avenue and East New York Avenue staircases had new metal treads. The remaining steps were still chipped and broken. (See photograph on page 3 of Appendix II.) All other prior conditions existed: there was crumbling concrete on the westbound platform (see photograph on page 4 of Appendix II); graffiti on the westbound walls and shed; and no station identification signs on the platform.

EAST NEW YORK – Chipped and cracked steps on the Van Sinderen Avenue staircase. Condition existed last year. Observed: July 5, 2001

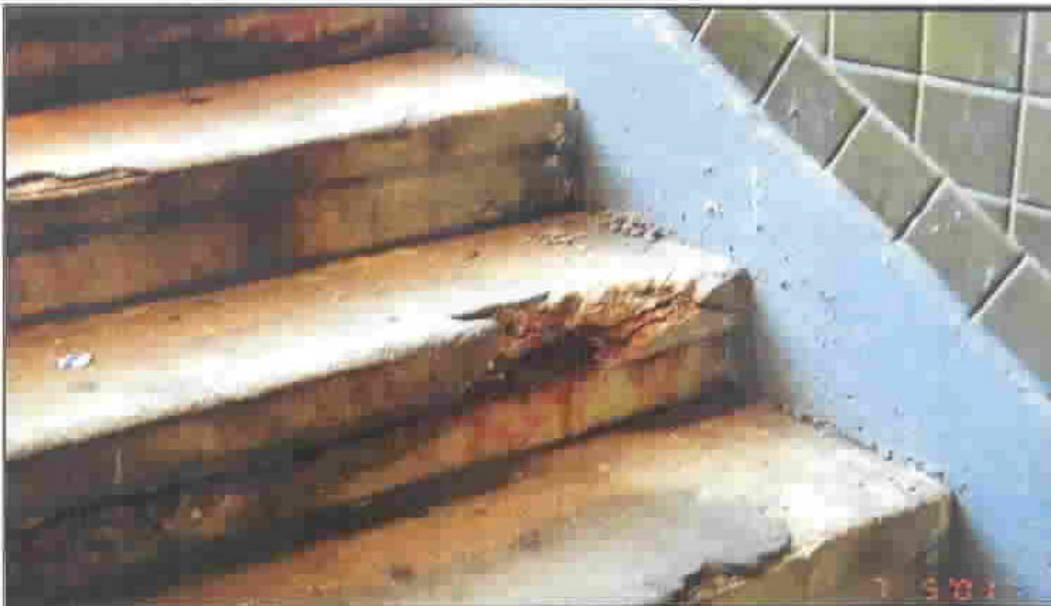
In addition to the conditions found in our prior audit that were not addressed, there was a large loose piece of concrete on the westbound platform. Also, the rear westbound staircase had chipped and broken steps. (See photograph on page 3 of Appendix II.) There were leaks on the front and rear portion of the eastbound platform and a raised expansion joint located at the front of the eastbound platform.

EAST NEW YORK – Chipped and broken steps on the westbound staircase. Observed: July 5, 2001

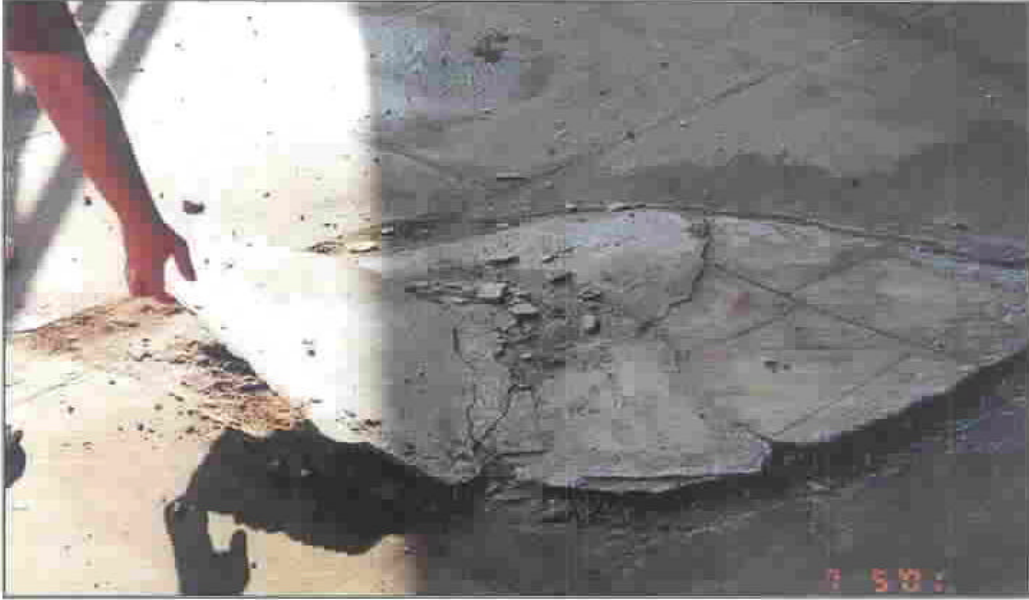
EAST NEW YORK – Broken concrete on the westbound platform. Condition existed last year.
Observed: July 5, 2001

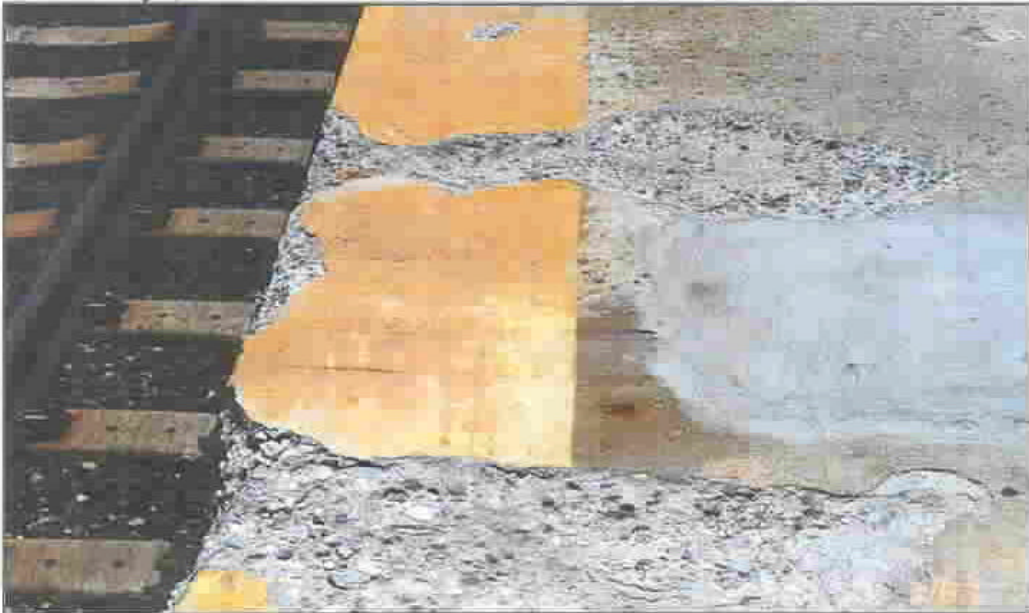
Additional Problems : The edges of the eastbound platform were cracked and had crumbling cement. (See photograph on page 4 of Appendix II.) One window on the westbound staircase was cracked and a window on the ticket office door was cracked. Graffiti was found under the westbound platform.

FOREST HILLS – Broken concrete edge at the rear of the eastbound platform.
Observed: July 3, 2001

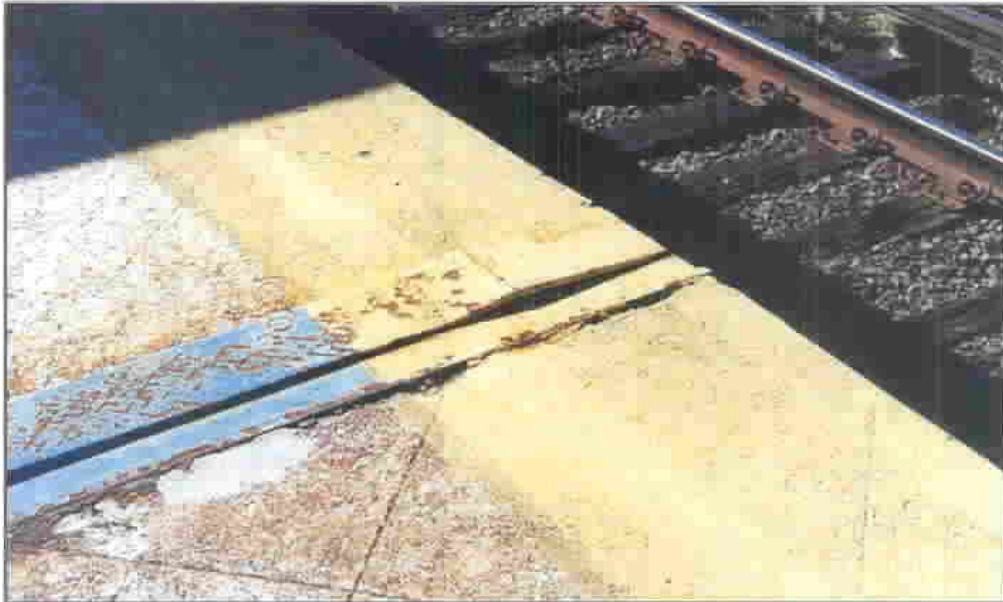
Additional Problems : There was a large area of broken concrete on platform's westbound side. There were raised expansion joints at the front and rear of the eastbound side of the platform. (See photographs on page 5 of Appendix II.) There was broken glass from the windowpanes of the waiting room door.

LAURELTON – Raised expansion joint at the front of eastbound side of the platform.
Observed: July 3, 2001

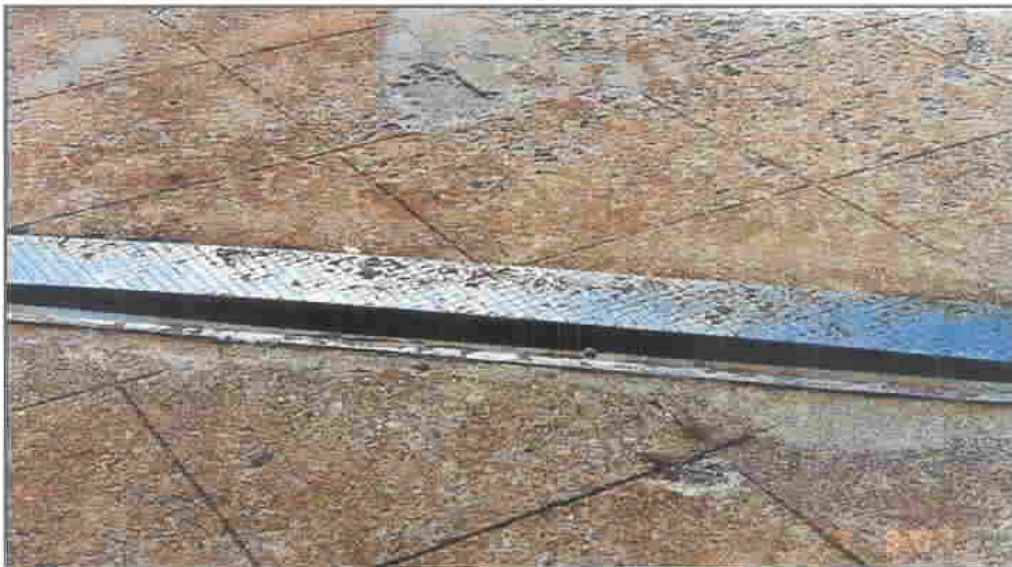
LAURELTON – Raised expansion joint at the rear of the eastbound side of the platform.
Observed: July 3, 2001

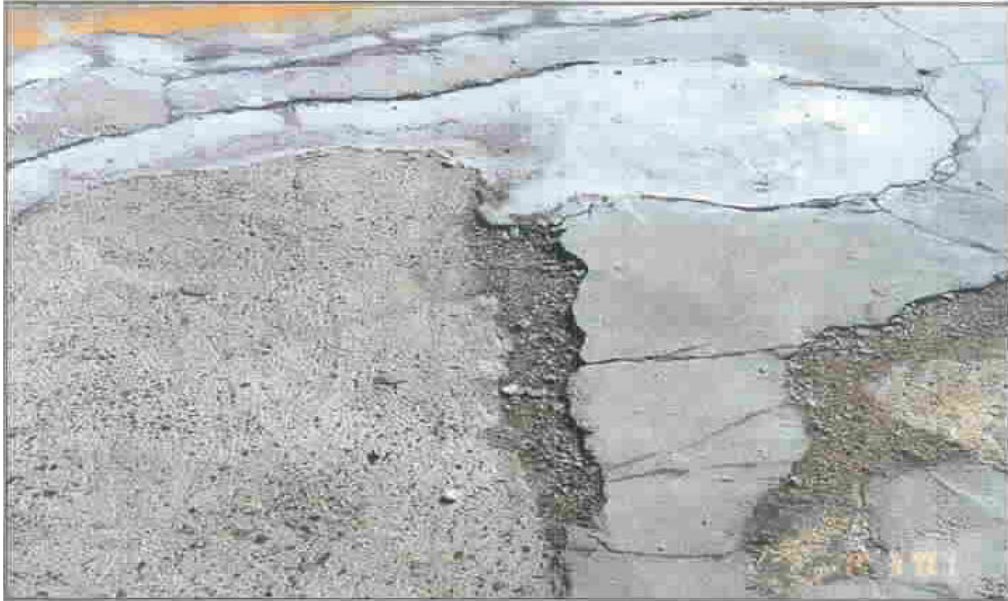
Current Status : Partially corrected. Some of the broken concrete was repaired. Other sections of broken concrete and the peeling paint conditions remain uncorrected. (See photographs on page 6 in Appendix II.)

LAURELTON – Broken and crumbling concrete on the westbound side of the platform. Condition existed last year. Observed: July 3, 2001

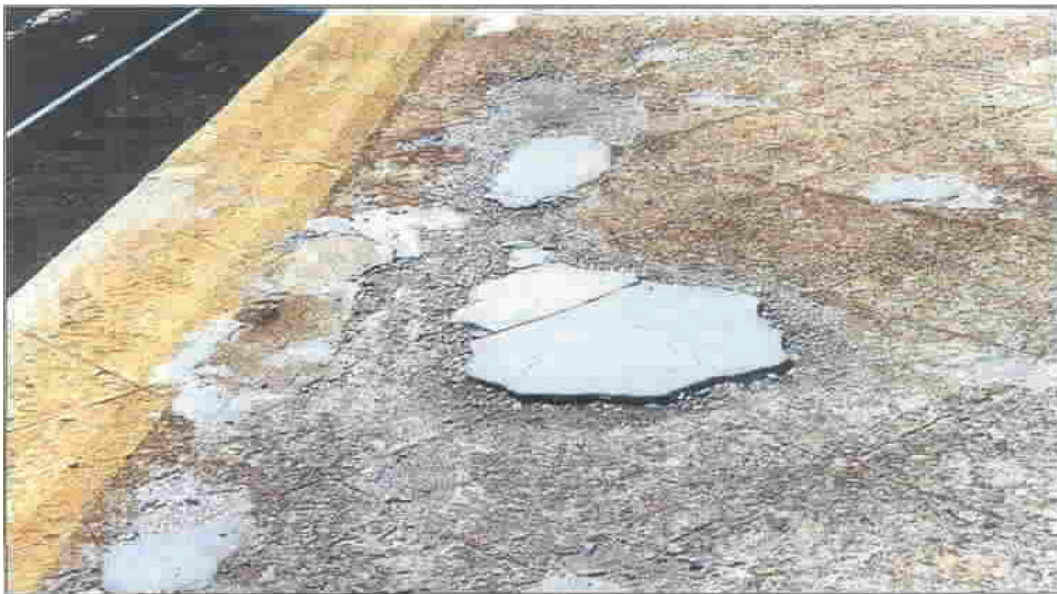
LAURELTON – Large area of broken and crumbling concrete on the westbound side of the platform. Condition existed last year. Observed: July 3, 2001

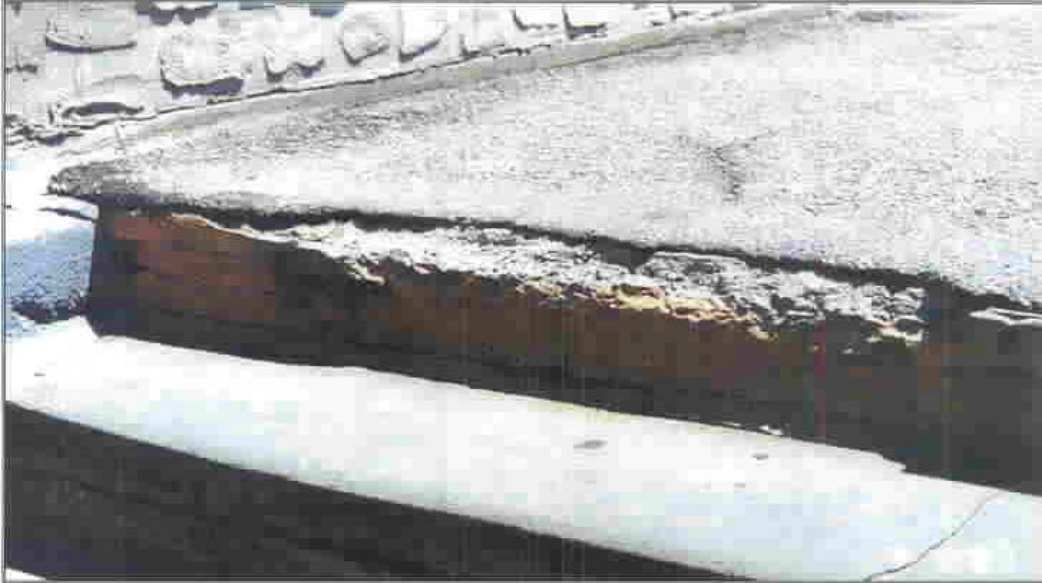
corrected. The steps on the westbound staircase remained chipped, the asphalt at the top of the westbound staircase was cracked, and one of its steps was chipped. The eastbound staircase had a chipped step. The edge of the eastbound platform had a loose metal plate. The ceiling above the westbound staircase leaked. Water from the retaining wall leaked onto the rear of the eastbound platform. The rusted pipes were only partially painted. (See photographs on pages 7, 8, 9, and 10 of Appendix II.) There was graffiti on the walls.

MURRAY HILL – Chipped concrete and broken asphalt at the top of the westbound staircase. Condition existed last year. Observed: July 2, 2001

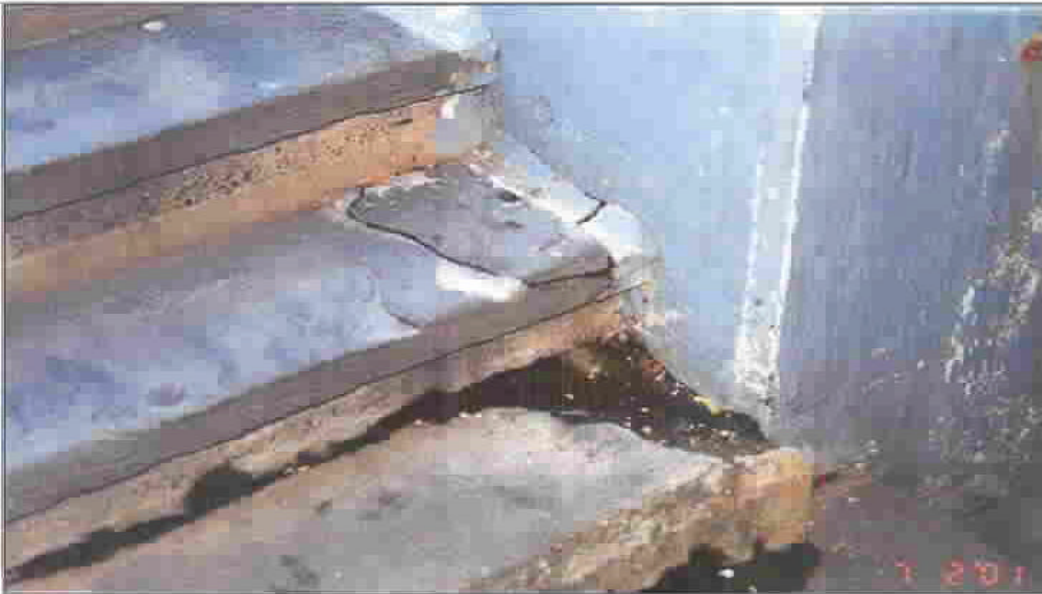
MURRAY HILL – Broken and chipped steps on the eastbound staircase. Condition existed last year. Observed: July 2, 2001

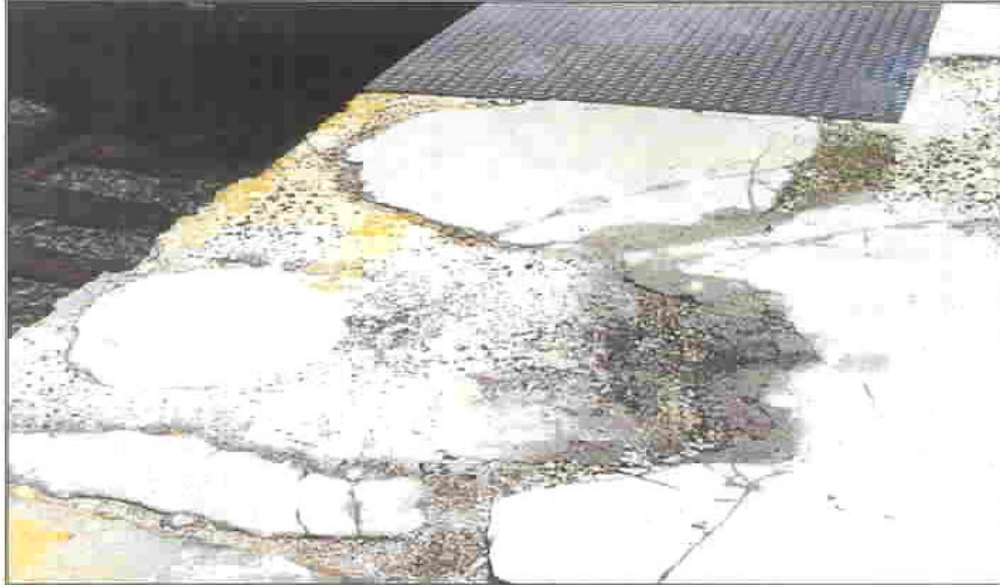
MURRAY HILL – Rough and uneven concrete on the eastbound platform. Condition existed last year. Observed: July 2, 2001

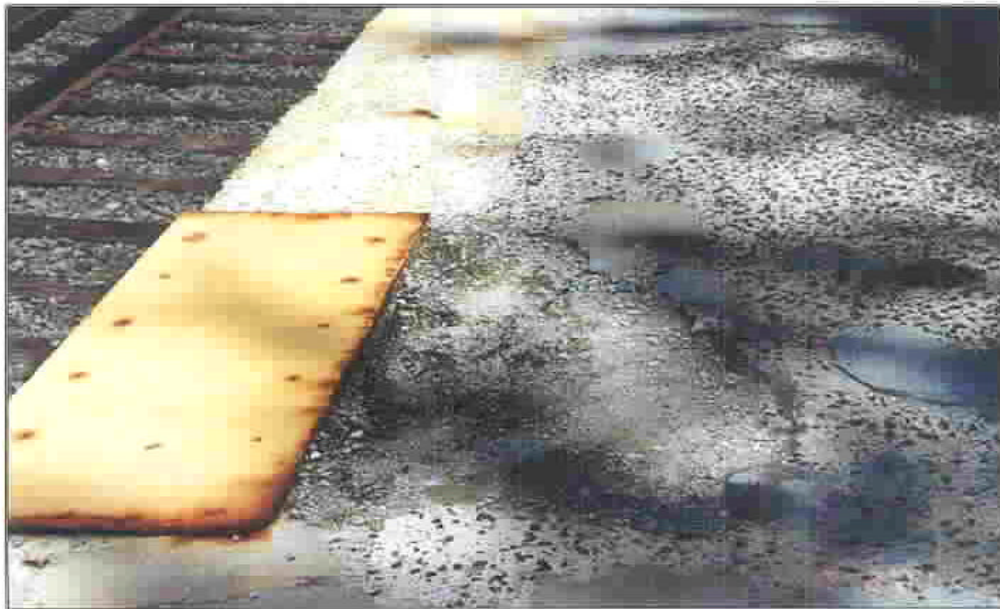
MURRAY HILL – Cracked and broken concrete on the eastbound platform. Condition existed last year. Observed: July 2, 2001

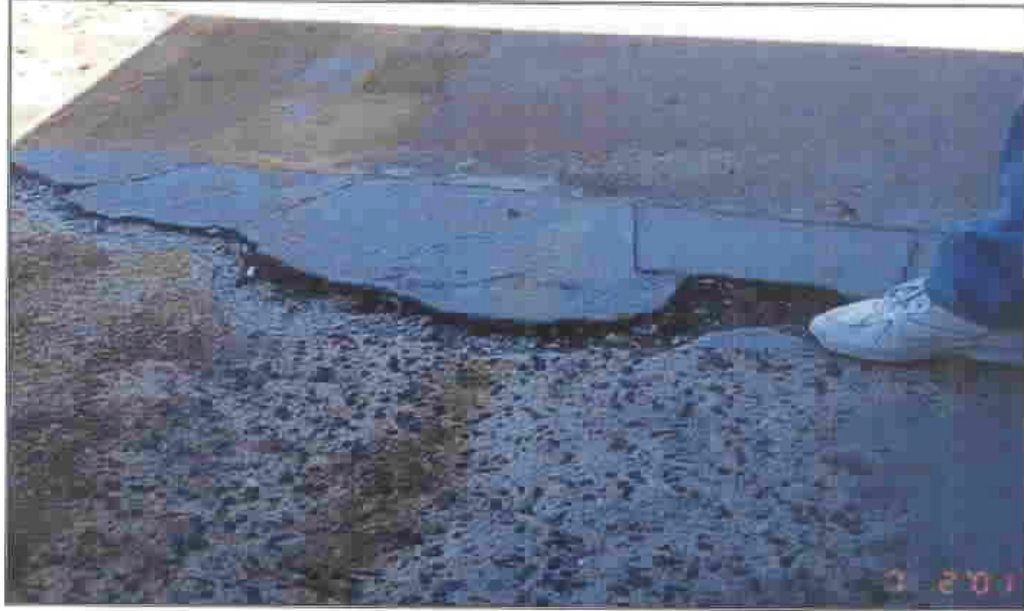
MURRAY HILL – Broken and crumbling concrete on the eastbound platform. Condition existed last year. Observed: July 2, 2001

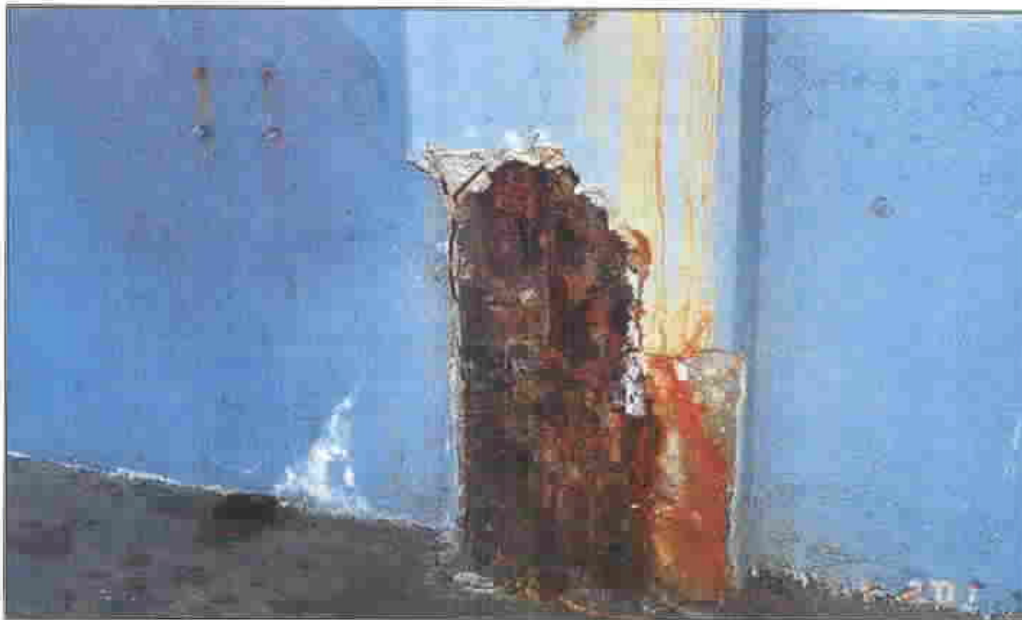
A large piece of concrete broke from the support beam, causing a large of area of rust to form on the eastbound platform. (See photograph on page 9 of Appendix II.)

MURRAY HILL – Broken concrete exposing a rusted support beam on the eastbound platform. Observed: July 2, 2001

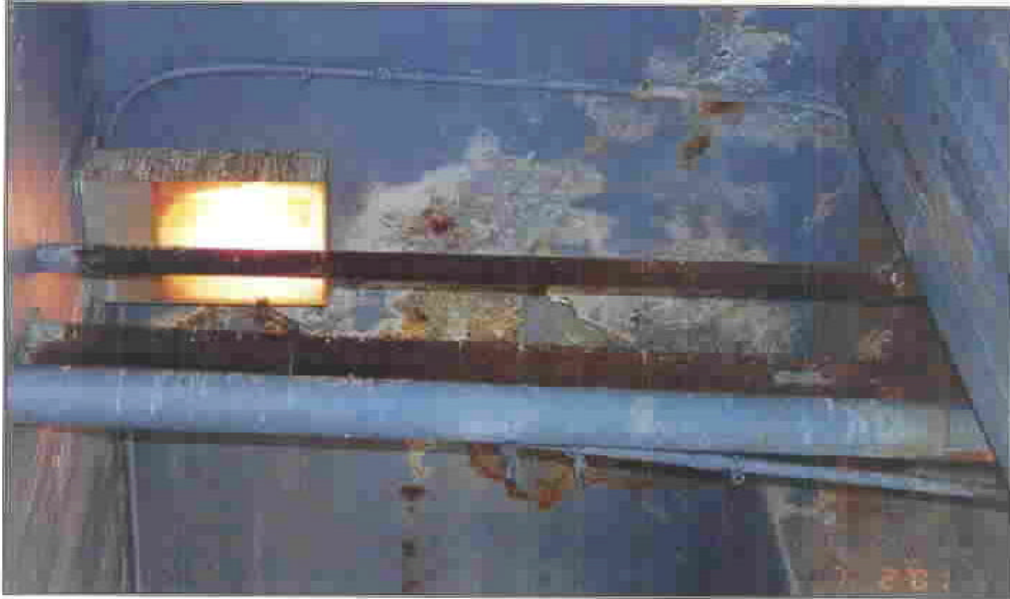
MURRAY HILL – Rusted pipes only partially painted above the westbound staircase. Condition existed last year. Observed: July 2, 2001

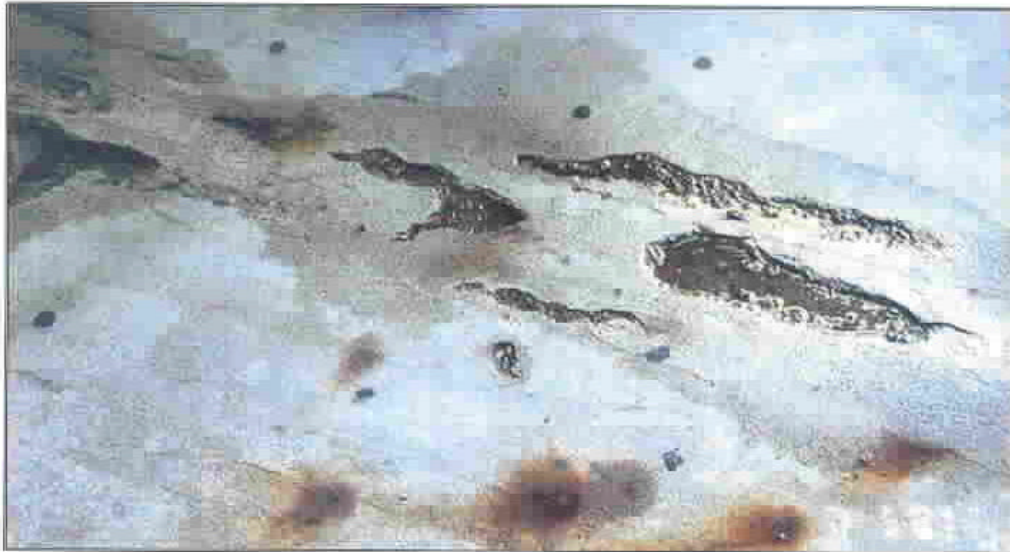
Sections of the eastbound platform sheds were missing. There was broken concrete on the front portion of the westbound platform and a broken platform edge on the westbound platform. (See photograph on page 10 of Appendix II.)

NOSTRAND AVENUE – Cracked and broken concrete on the westbound platform. Observed: July 5, 2001

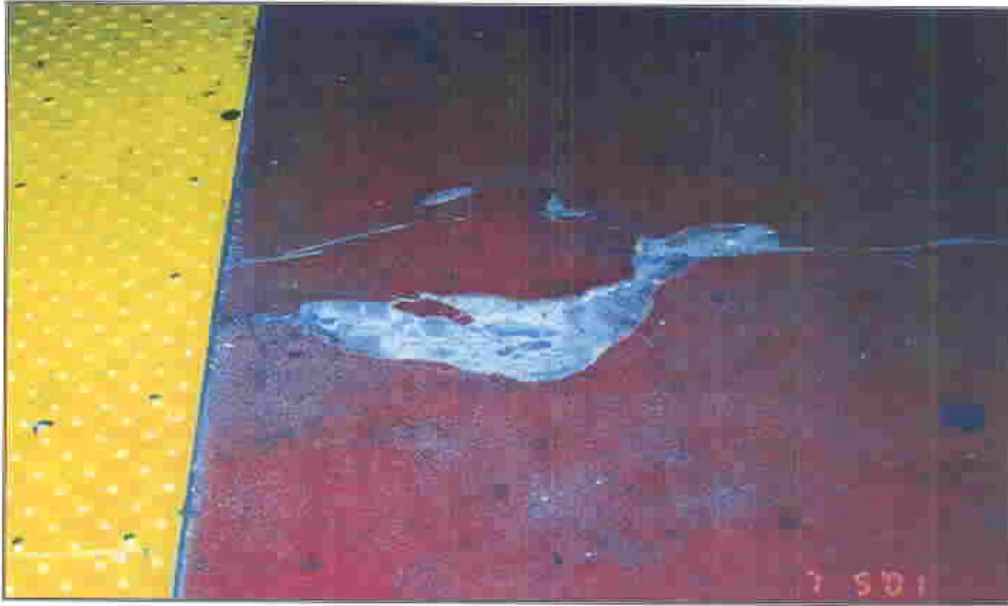
There were leaks above the Track 15-16, 17, and 18-19 platforms. There was broken concrete in the middle of the Track 13 platform, and cracked tiles by the Track 14 escalator. (See photograph on page 11 of Appendix II.)

PENN STATION – Broken concrete on the Track 13 platform. Observed: July 5, 2001

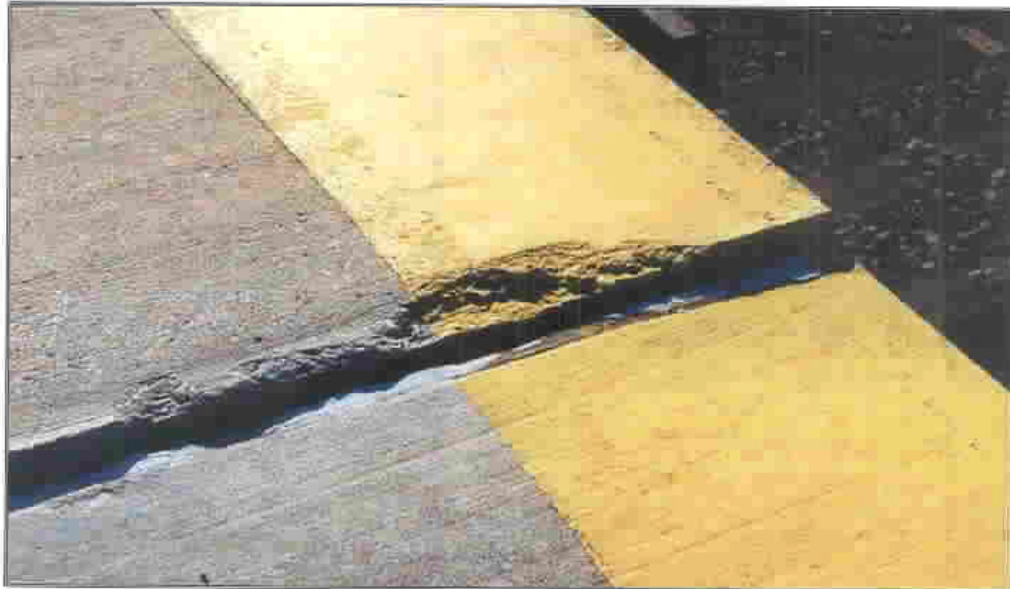
Current Status: Partially corrected. The chipped step on the eastbound staircase was repaired. However, the gap between the raised pavement on the westbound platform still exists. (See photograph on page 11 of Appendix II.)

QUEENS VILLAGE – A large gap on the westbound platform. Condition existed last year. Observed: July 3, 2001

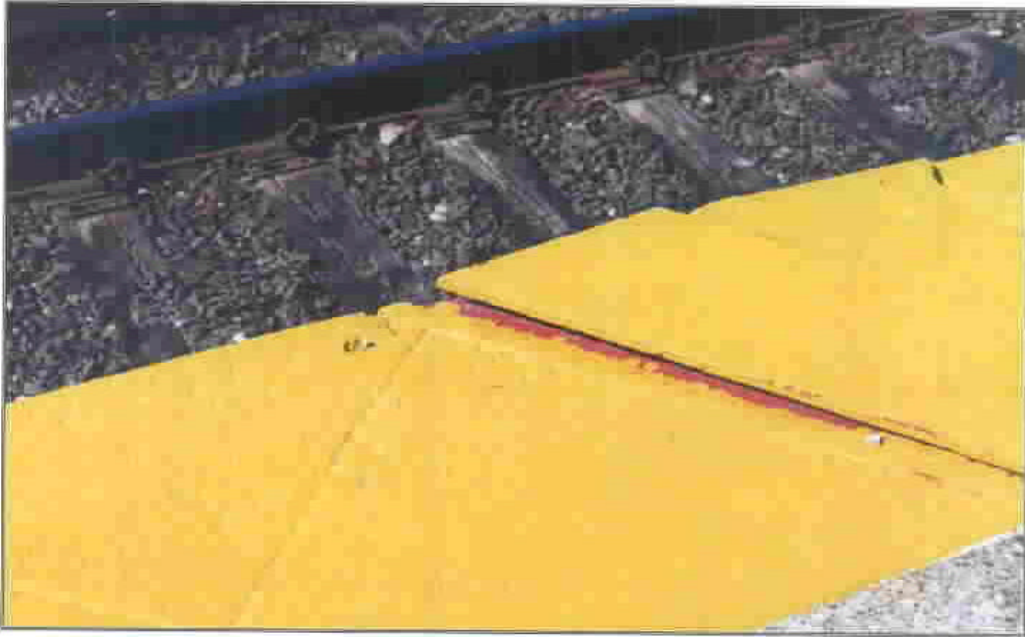
Additional Problems: There were raised expansion joints at the front and middle sections on the eastbound side of the platform. There was broken concrete on the platform's eastbound side. There were broken platform edges in the front section of the eastbound side of platform. (See photographs on pages 12 and 13 of Appendix II.) Broken glass was on the west-side staircase.

ROSEDALE – A raised expansion joint on the eastbound side of the platform. Observed: July 3, 2001

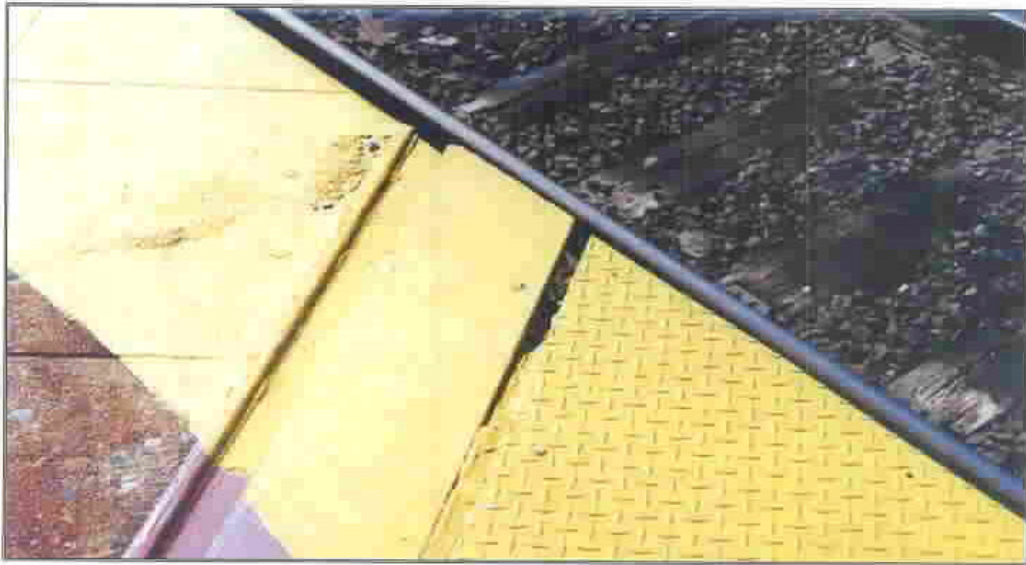
ROSEDALE – A raised expansion joint on the eastbound side of the platform. Observed: July 3, 2001

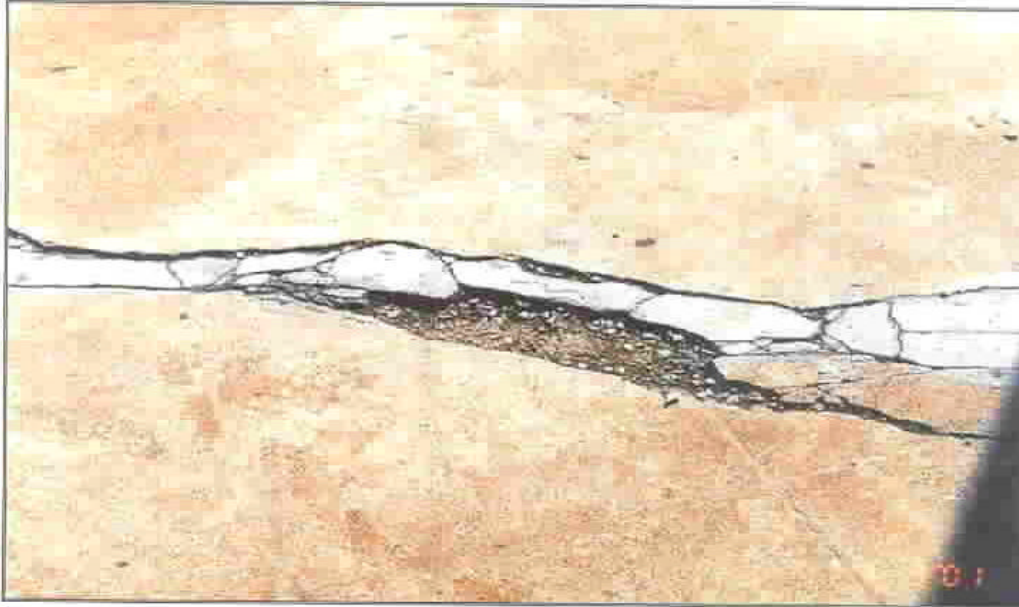
ROSEDALE – Broken and crumbling concrete on the eastbound side of the platform.
Observed: July 3, 2001

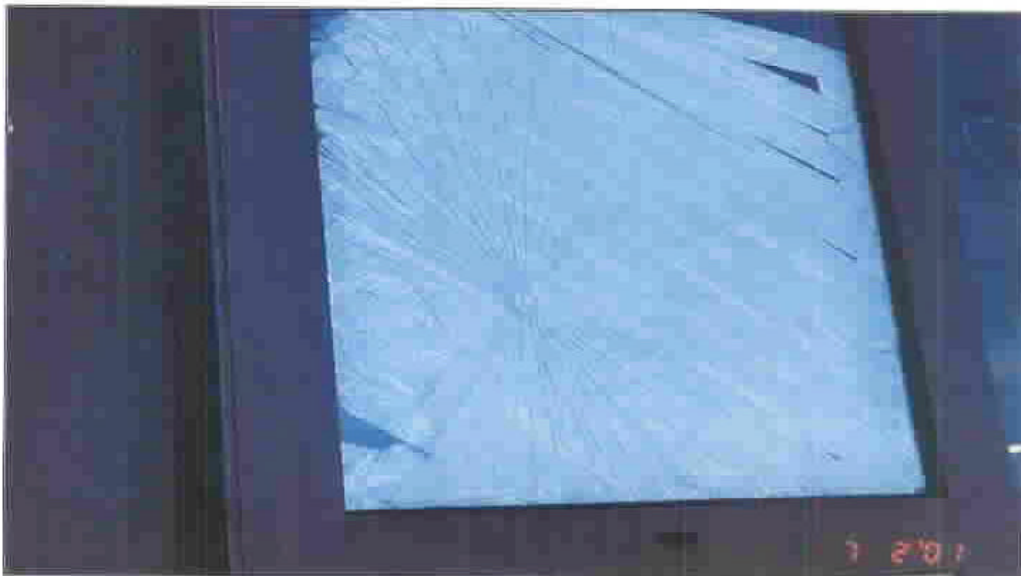
Current Status : Partially corrected. The graffiti on the station's westbound and eastbound platforms had been cleaned. The window at the passenger overpass for platform A-B was covered with duct tape only on the inside and had not been fully repaired. (See photograph on page 13 of Appendix II.)

WOODSIDE – A broken glass window covered on the inside with only duct tape on the eastbound staircase. Condition existed last year. Observed: July 2, 2001
