**Audit Report on the
Metropolitan Transportation Authority's
Maintenance of Metro-North Railroad Stations
Within the City**

FN01-191A

February 20, 2002

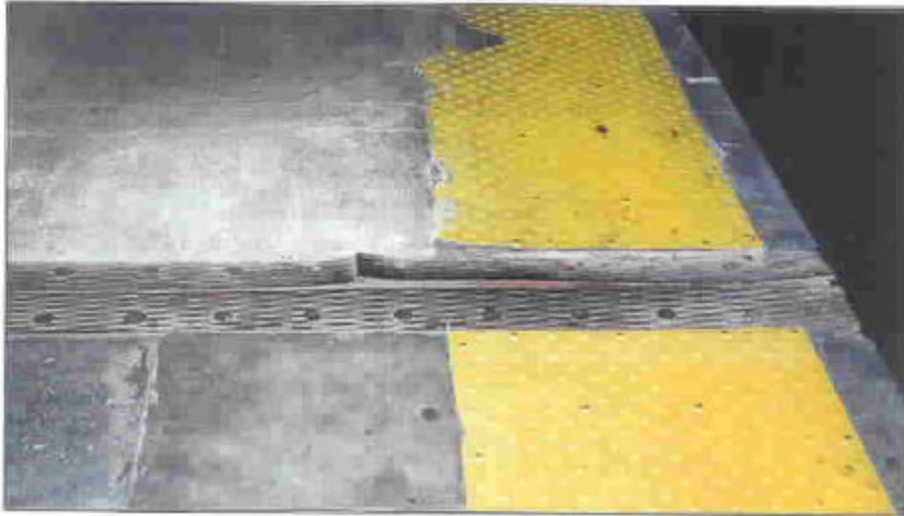
GRAND CENTRAL TERMINAL – Raised expansion joint on platform on Track 29.
Observed: July 11, 2001

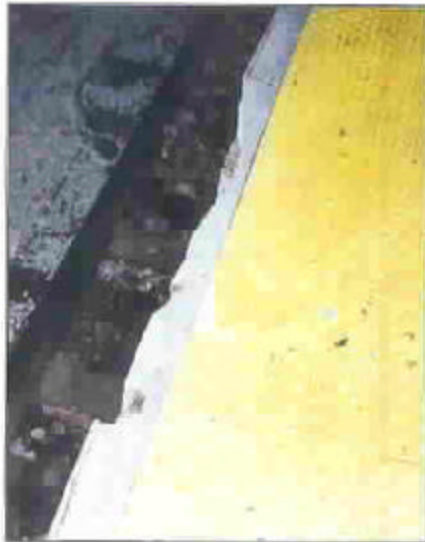
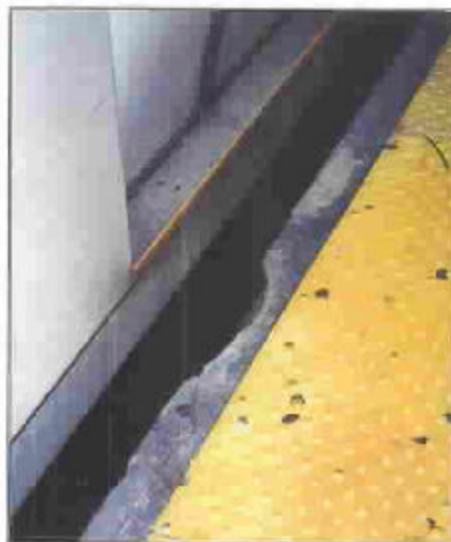
GRAND CENTRAL TERMINAL - Broken platform edges on Track 15 (Left). Broken platform edges on Track 24 (Right). Observed: July 11, 2001

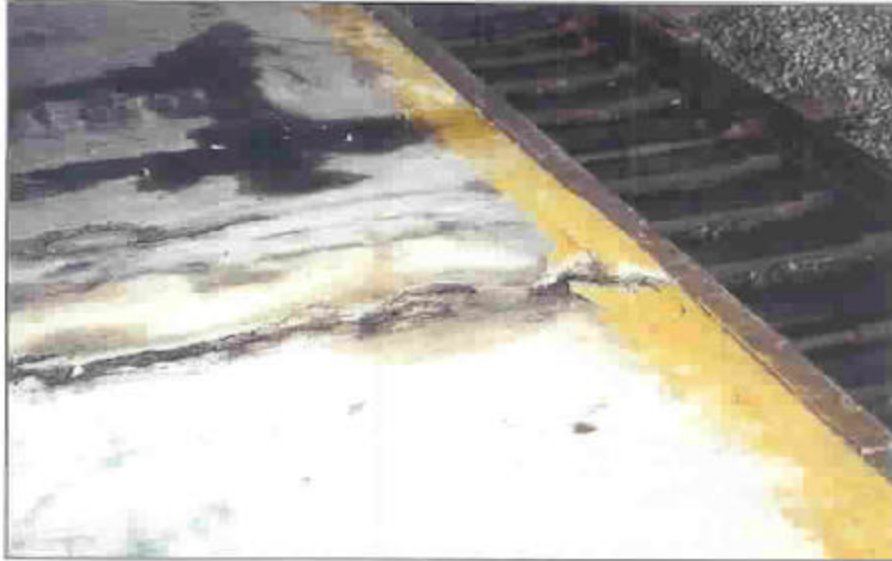
Additional Problems: There was broken concrete on the northbound and southbound platforms. Broken edges on the northbound platform left metal rods exposed. (See photographs on page 2 in Appendix II.) New litter and broken glass were on the station's northbound platform.

MELROSE – Broken concrete on northbound platform. Observed: July 9, 2001

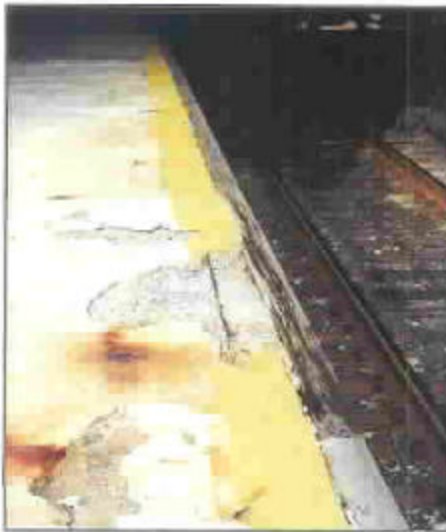
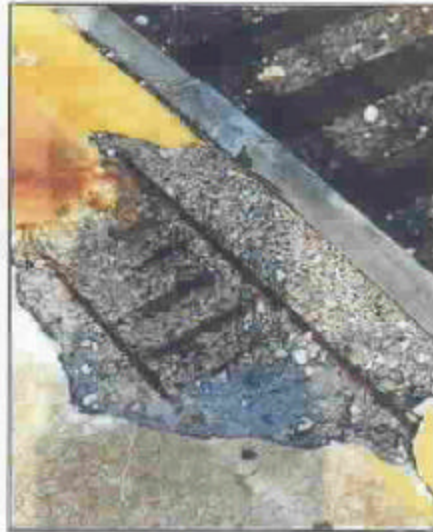
MELROSE – Broken area of concrete on northbound platform (Left). Broken platform edge exposing metal rods on northbound platform (Right). Observed: July 9, 2001

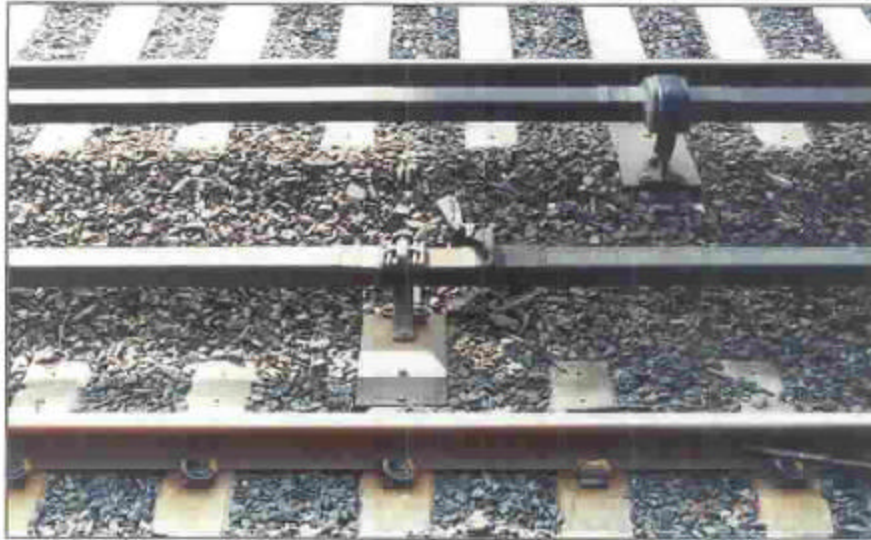
Additional Problems: The northbound and southbound staircases had broken steps. The southbound platform had a loose edge-board and broken concrete. Third rails on the southbound track were exposed and missing their protective sleeve covers. (See photographs on pages 3 and 4 in Appendix II.)

TREMONT – Exposed third rail on southbound track. Observed: July 9, 2001

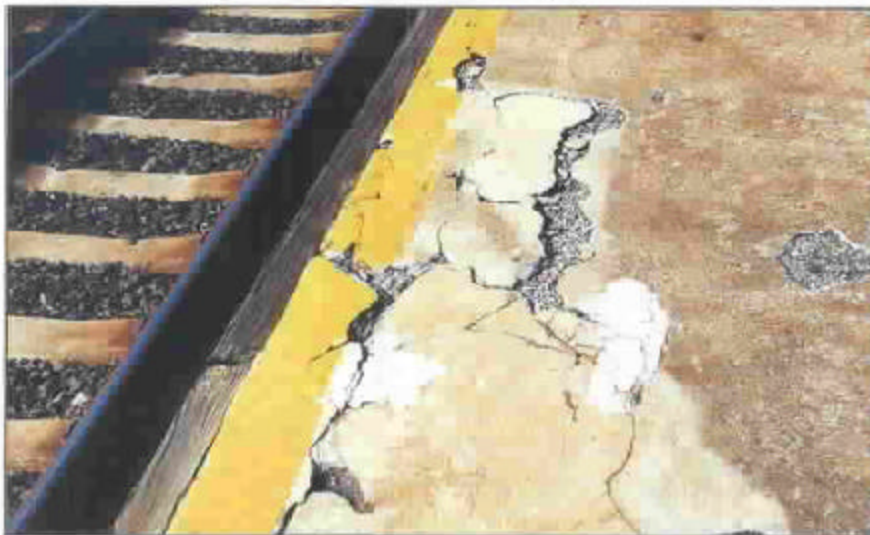
TREMONT – Broken concrete by edge on the southbound platform. Observed: July 9, 2001

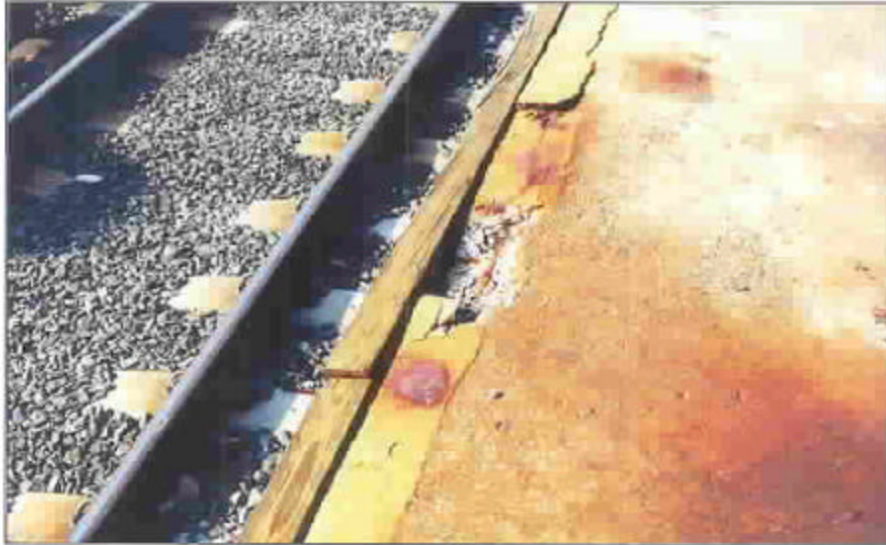
TREMONT – Broken concrete edge and loose edgeboard on southbound platform.
Observed: July 9, 2001

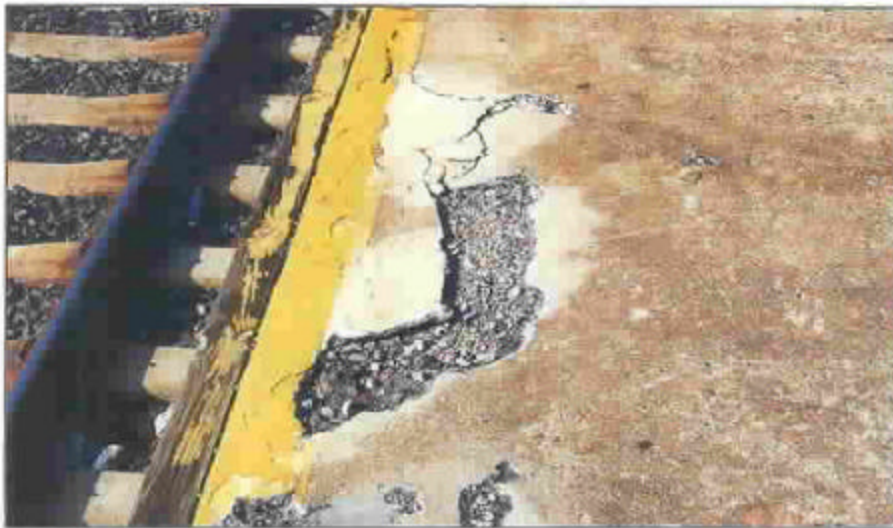
TREMONT – Broken concrete on southbound platform. Observed: July 9, 2001

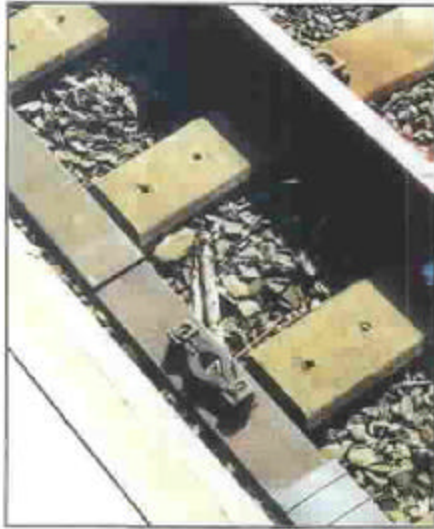
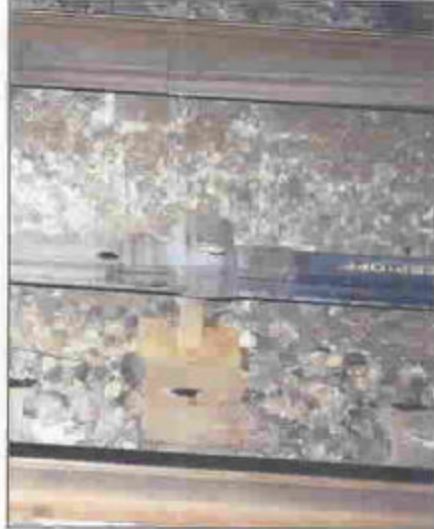
Additional Problems: In addition to not correcting the above conditions, there were additional third rail caps missing, broken concrete by the edge on the southbound platform, and broken edges that exposed rusted metal rods on the southbound platform. (See photographs on page 5 in Appendix II.)

FORDHAM – Exposed third rail by southbound platform (Left). Exposed third rail on southbound track (Right). Conditions existed last year. Observed: July 9, 2001

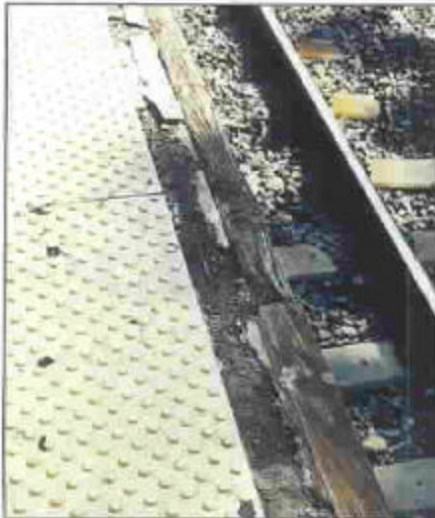
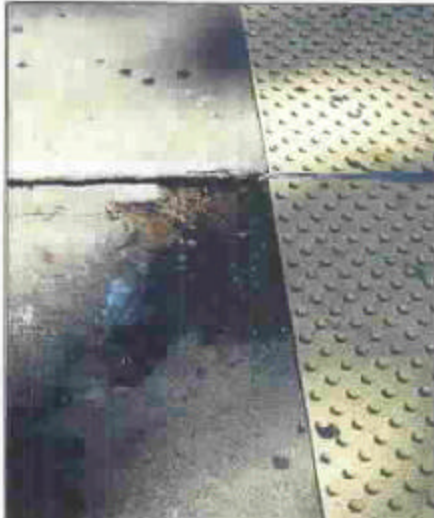
FORDHAM – Broken platform edge on southbound platform, exposing rusty metal rods (Left). Broken concrete on southbound platform (Right). Observed: July 9, 2001

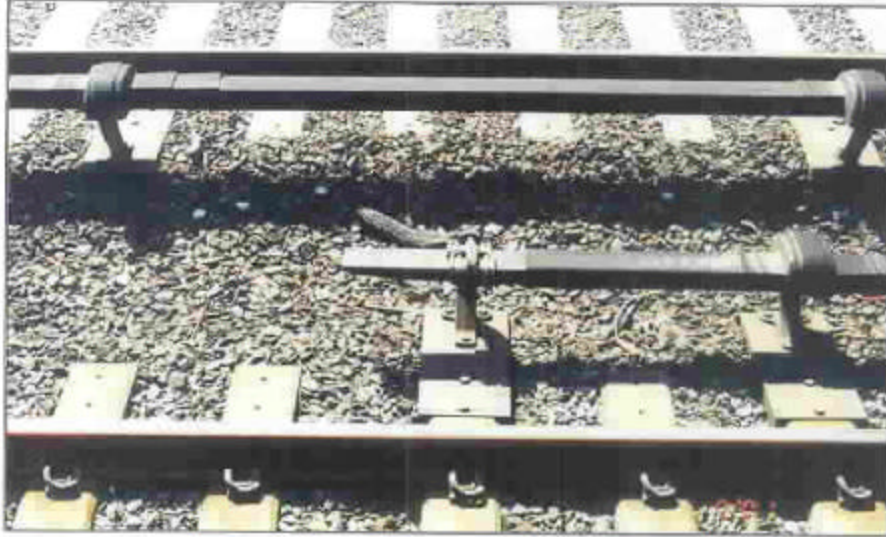
Additional Problems: Third rails were missing sleeves and caps. (See photographs on page 6 in Appendix II.) Glass in the window on the southbound pedestrian overpass was cracked. Graffiti was on the southbound platform.

BOTANICAL GARDEN – Exposed third rail and missing cap in the front of the southbound track.
Observed: July 9, 2001

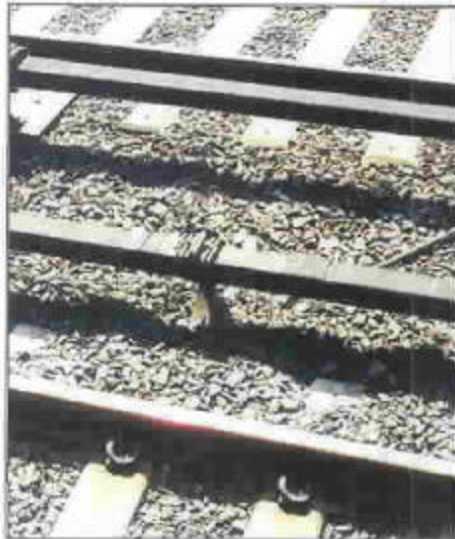
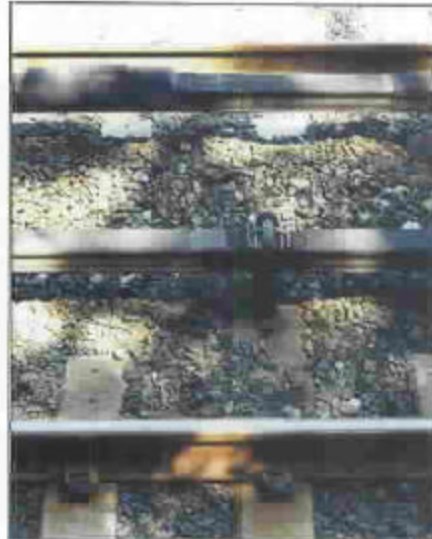
BOTANICAL GARDEN – Exposed third rail and missing cap on the rear of the southbound track (Left). Exposed third rail and missing cap on the northbound track (Right). Observed: July 9, 2001

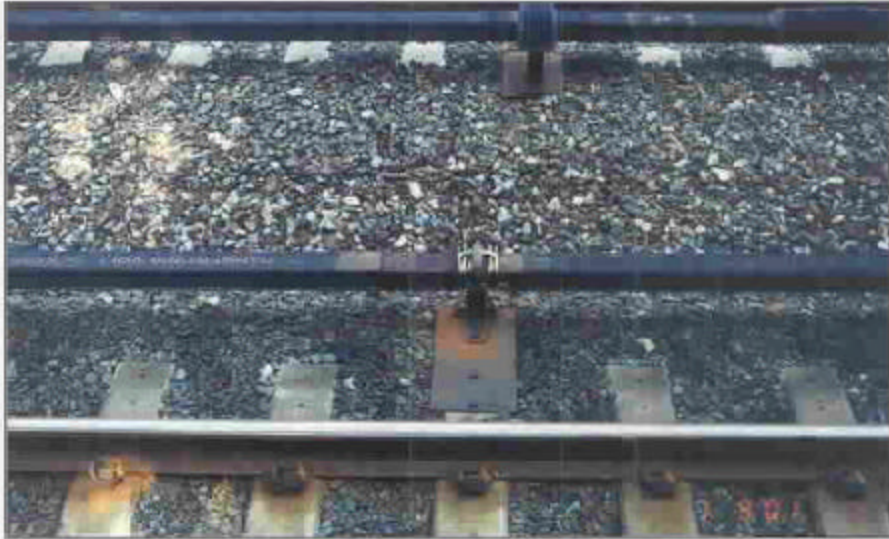
Additional Problems: There were exposed third rails on both the northbound and southbound tracks. (See photographs on page 7 in Appendix II.) The northbound platform shelter had two broken windows. There was litter at the rear of the northbound platform.

WILLIAMS BRIDGE – Exposed third rail and missing cap on northbound track.
Observed: July 9, 2001

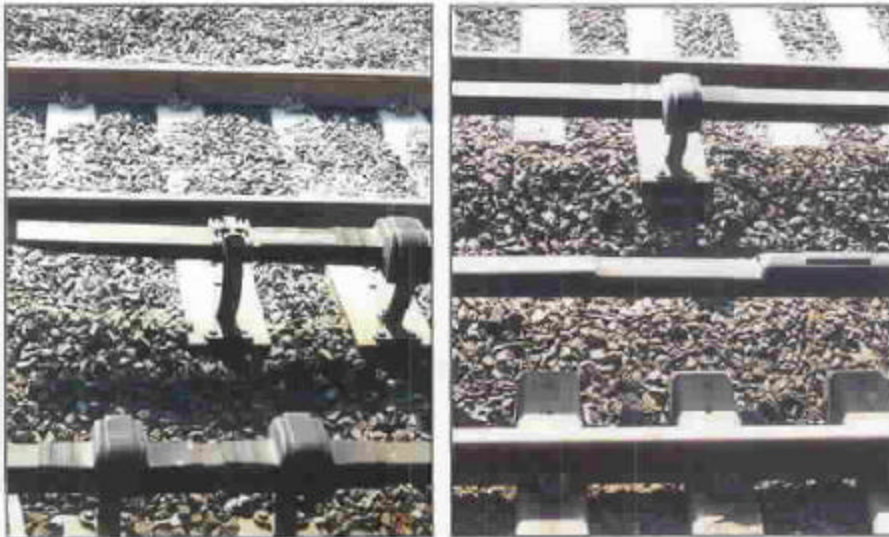
WILLIAMS BRIDGE – Exposed third rail and missing cap on southbound track (Left). Exposed third rail on the southbound track (Right). Observed: July 9, 2001

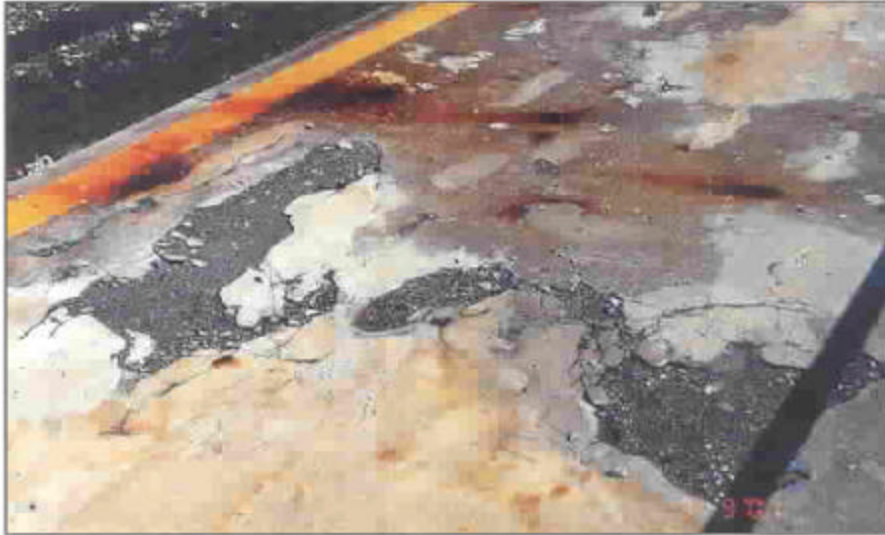
Additional Problems: There was broken and loose concrete on the northbound platform edge and the southbound platform. A rusted metal rod protruded from broken concrete on the southbound platform. (See photographs on page 8 in Appendix II.)

- During routine inspections conducted at the Wakefield Station from May 2000 through June 2001, Metro-North's Customer Service and Operation Services Department cited loose, spalling, and cracked concrete on both platforms; there was chipped paint on the walls, stairs, and canopy; and graffiti on the stairway, walls, and canopy. We observed these same conditions during our inspections of Wakefield in July and August 2001. (See photographs on page 8 in Appendix II.)

WAKEFIELD – Large area of broken and spalling concrete on the southbound platform.
Observed: July 9, 2001

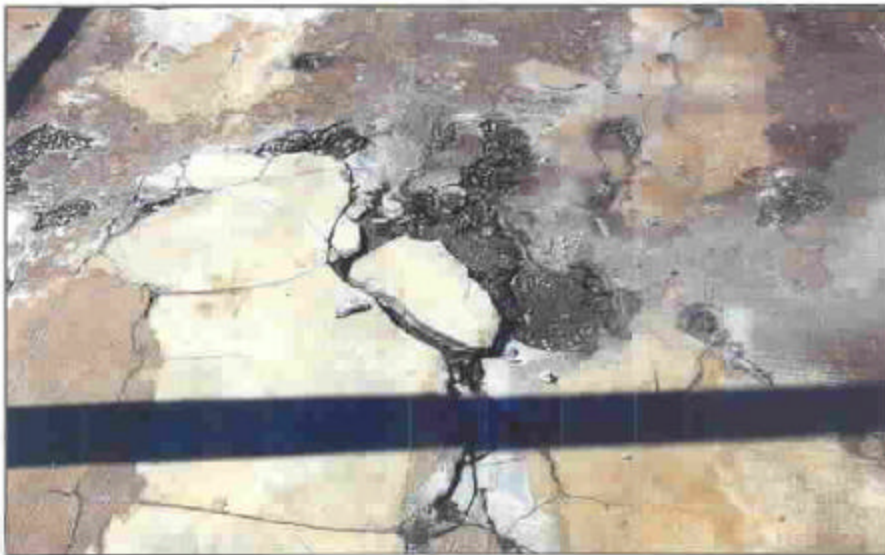
WAKEFIELD – Broken concrete on the southbound platform. Observed: July 9, 2001

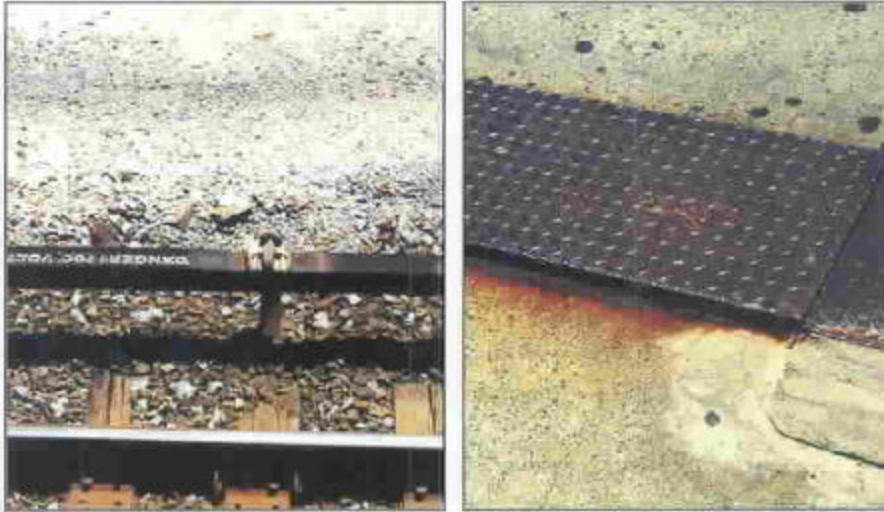
Additional Problems: A different metal expansion plate was loose and uneven at the entrance. There were exposed third rails without caps on the northbound and southbound tracks. The southbound side of the platform had loose, splintered, and missing sections of its edge-boards. (See photographs on page 9 in Appendix II.) There was loose concrete on the northbound side of the platform.

MORRIS HEIGHTS – Exposed third rail and missing cap on the northbound track (Left). Loose expansion joint with gap at entrance of staircase (Right). Observed: July 9, 2001

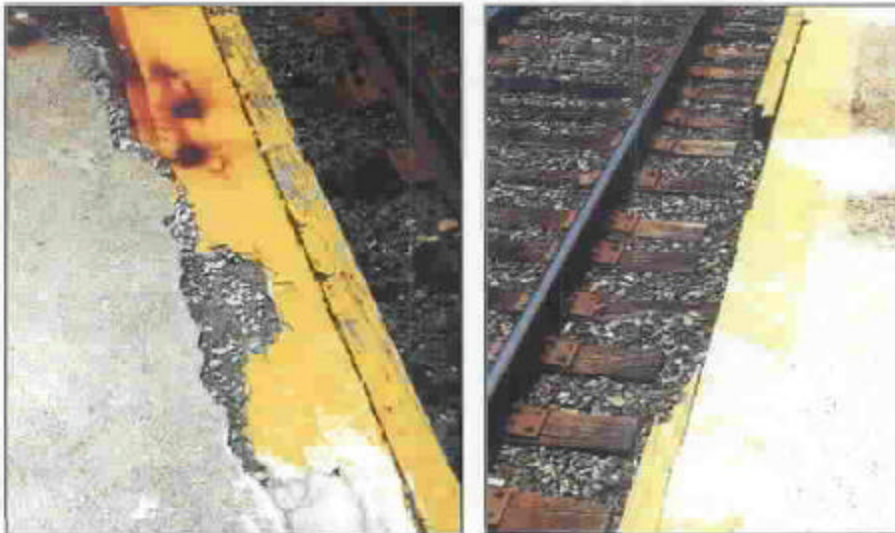
MORRIS HEIGHTS – Broken and spalling concrete by edge on the rear southbound side of platform (Left). Missing edgeboard on southbound side of platform. Observed: July 9, 2001

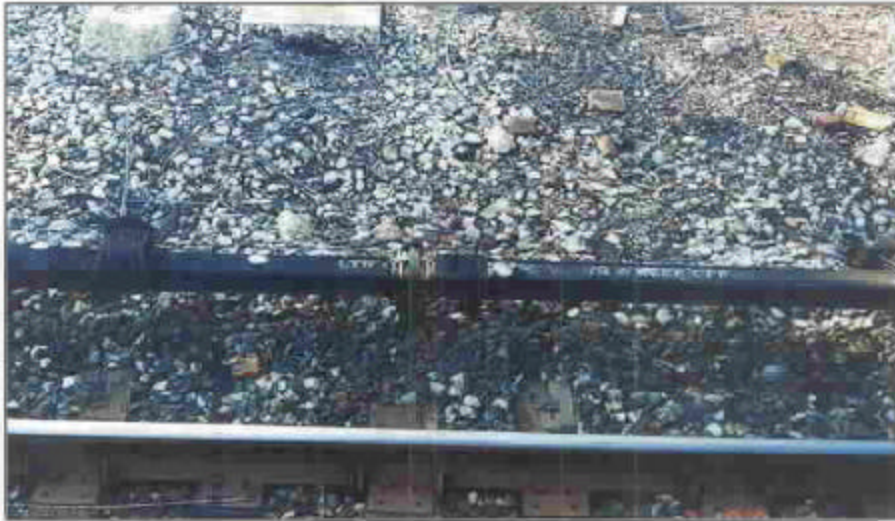
Additional Problems: Other sections of the platform had broken concrete that exposed metal rods. The northbound and southbound tracks had exposed sections of third rails. (See photographs on pages 10 and 11 in Appendix II.)

UNIVERSITY HEIGHTS – Missing cap on third rail on the northbound track.

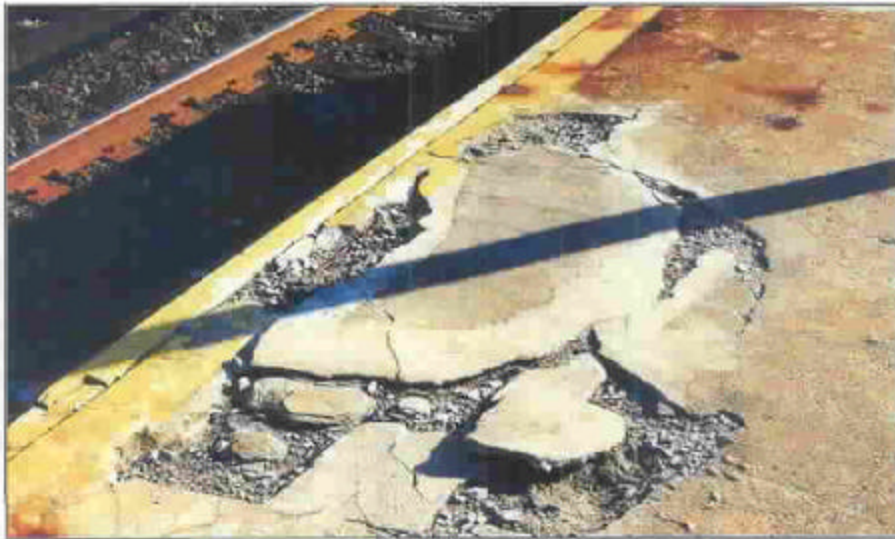
UNIVERSITY HEIGHTS – Large section of broken and spalling concrete by the edge of the southbound side of the platform. Condition existed last year. Observed: July 10, 2001

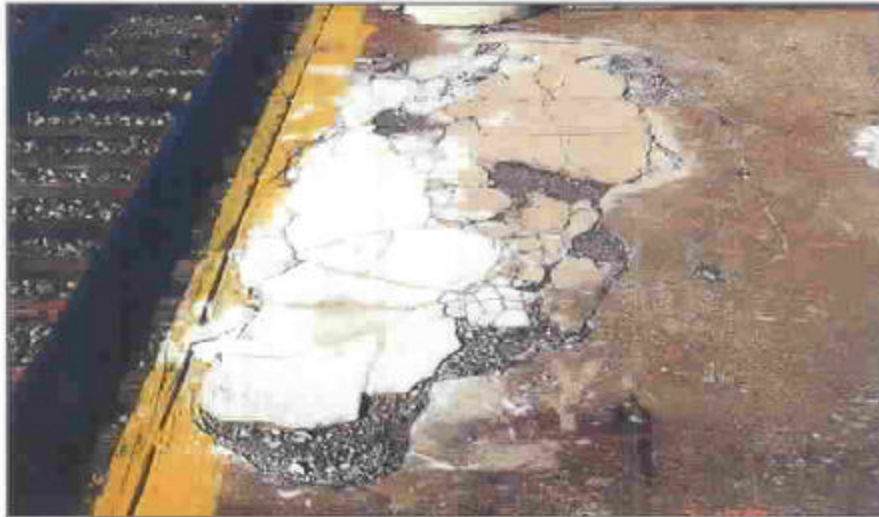
Current Status: Partially corrected. Some concrete repairs had been made; however, there were still areas where cement was cracked and crumbling. (See

- Metro-North's Operation Services Department reported in its February and March 2001 inspections that there were "fresh patches" of concrete on the University Heights Station platform. However, as of May and June 2001, the Operation Services Department noted that the patches did not last. During our inspections of this station in July and August 2001, we noted that large sections of the platform were cracked and crumbling. (See photographs on pages 10 and 11 in Appendix II.)

UNIVERSITY HEIGHTS – Large section of broken and spalling concrete on the rear of the northbound side of the platform. Condition existed last year. Observed: July 10, 2001

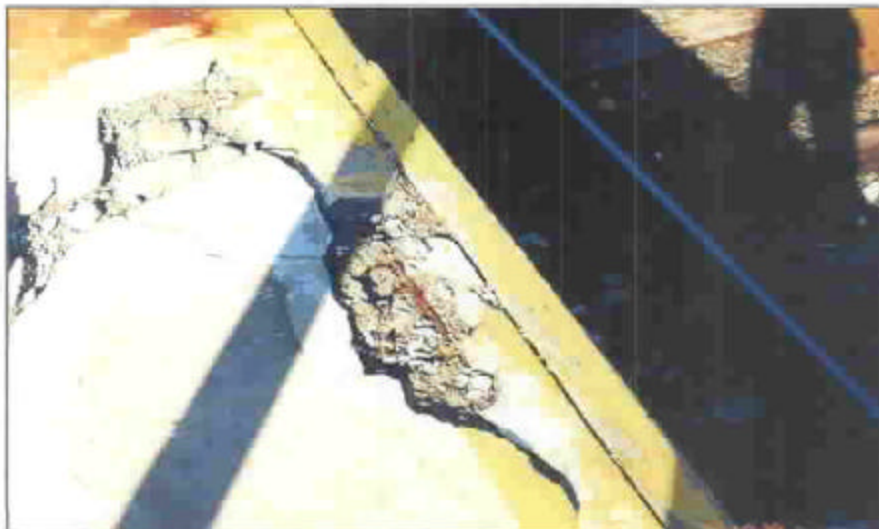
UNIVERSITY HEIGHTS – Broken and cracked concrete exposing rusty metal rod by the edge on the northbound side of the platform. Observed: July 10, 2001

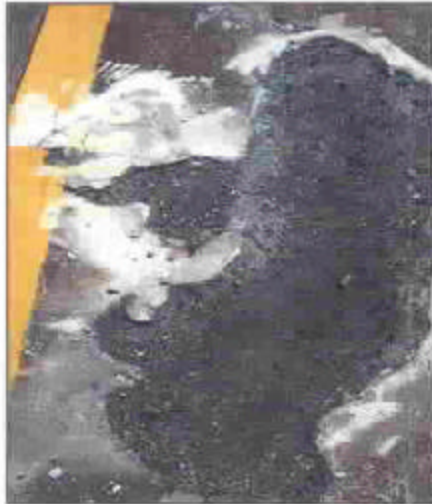
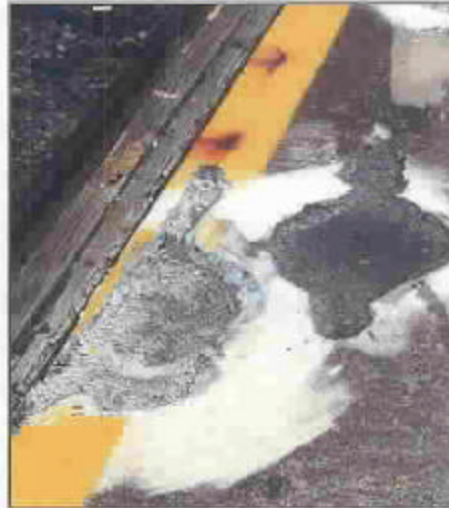
Additional Problems: There were exposed sections of third rails on the northbound track. Broken concrete created several holes on the northbound side of the platform. Broken concrete left exposed metal at the rear area of the southbound side of the platform. The southbound side of the platform had missing edge-board sections. (See photographs on page 12 in Appendix II.) There was broken glass on the northbound side of the platform.

MARBLE HILL – Large hole with spalling concrete on the northbound side of platform (Left). Holes with spalling concrete filled with water by edge on northbound side of platform (Right).
Observed: July 9, 2001

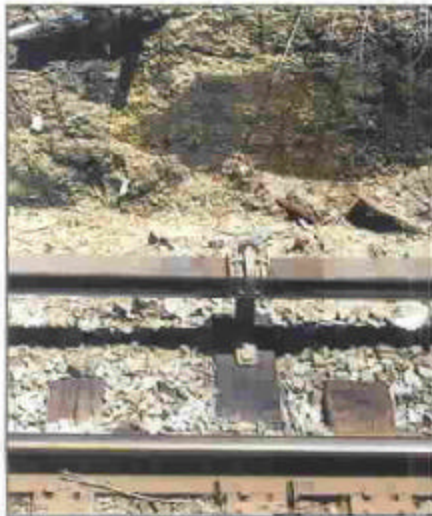
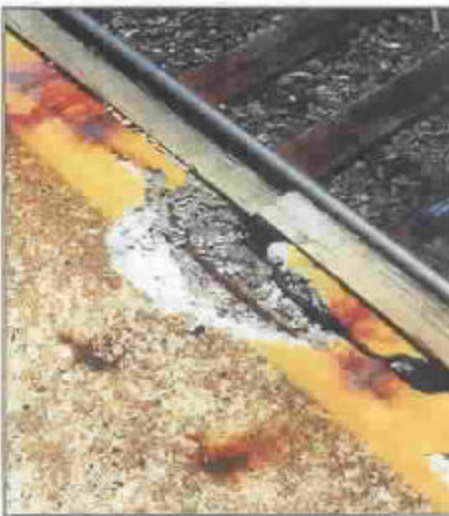
MARBLE HILL – Exposed third rail and missing cap on the northbound track (Left). Broken concrete exposing rusty metal rod by edge in rear of southbound side of platform (Right).
Observed: July 9, 2001

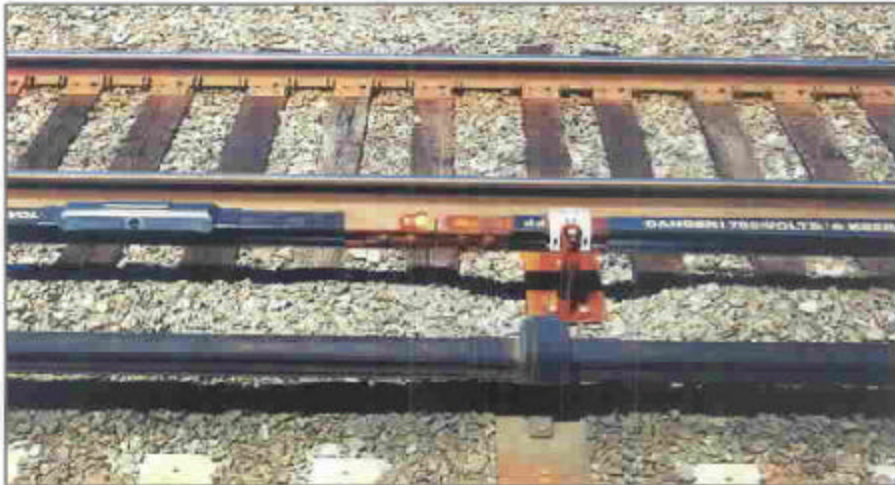
<u>Prior Conditions:</u>	Missing protective sleeve covers and caps caused sections of the third rails to be exposed. The southbound and northbound platforms had cracked and crumbling cement. There was rusted debris falling from a deteriorated staircase on the platform. The stairway railing was rusted, cement on the northbound platform was cracked and crumbling, pipes in the waiting area canopy and the overhead staircase had peeling paint, and the protective cover at the base of a lamppost on the southbound platform was missing, exposing the wires. There was graffiti on the walls of the northbound platform.
<u>Current Status:</u>	Partially corrected. The missing protective cover at the base of a lamppost on the southbound platform was replaced. Some concrete repairs had been made; however, the northbound and southbound platforms still have many areas where cement was cracked and crumbling. (See photographs on page 13 of Appendix II.) The staircase and the stairway railing had not been repaired and were still rusted. The pipes in the waiting area canopy and the overhead staircase still had peeling paint, and there was still graffiti on the walls of the northbound platform. Portions of the station's third rails were still missing caps and sleeves. (See photograph on page 13 in Appendix II.)

RIVERDALE – Exposed third rail and missing cap on northbound track. Condition existed last year. Observed: July 9, 2001

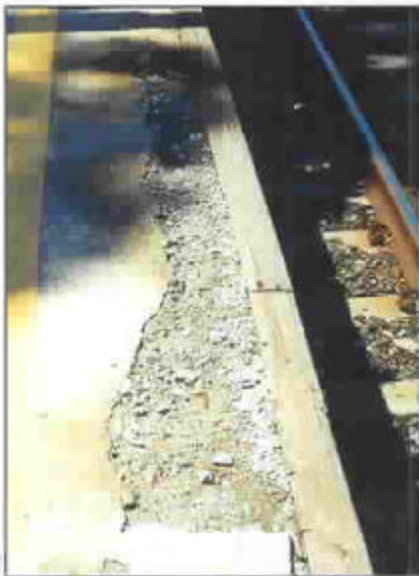
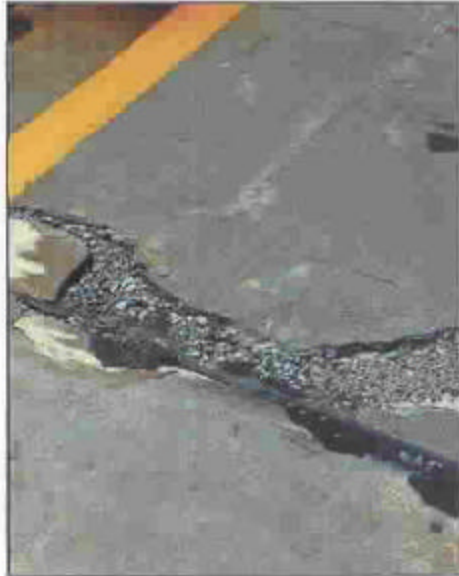
RIVERDALE – Large area of broken and spalling concrete by edge on the northbound platform (Left). Broken concrete, holes, and spalling concrete on front of southbound platform. Observed: July 9, 2001
