Audit Report on the
Department of Environmental
Protection's Maintenance of Rain
Gardens

SE18-086A

December 16, 2019

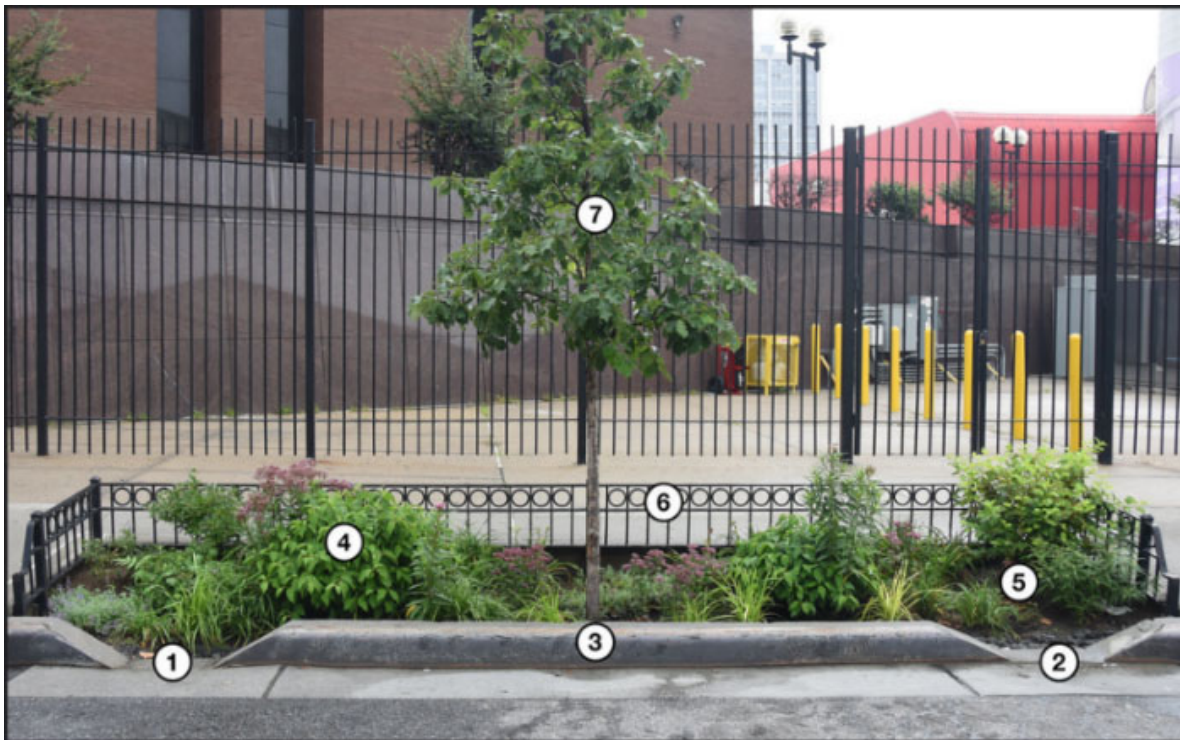
Figure 1 - How Rain Gardens Work (source: DEP)

Rain gardens contain plants and engineered soil that have been horticulturally designed to absorb large amounts of stormwater, thereby reducing the amount of water that enters the sewer system. A bowl-shaped depression in the garden holds the water so it can slowly infiltrate into the soil as the plants and mulch naturally remove pollutants from the runoff. For rain gardens to function as intended, an inlet curb cut allows the flow of stormwater runoff to enter the rain garden area.³ During heavy rain events, excess water that cannot be absorbed is discharged as runoff through an outlet curb cut. Gravel is used to filter debris and for protection, a metal tree guard rail surrounds the rain garden on three sides. Most rain gardens have a tree set in the center, surrounded by plants. According to DEP data, a typical standard rain garden—15' long, 5' wide, and 2.5' deep, will hold on average over 1,600 gallons of rainwater, the equivalent of about 20 bathtubs.⁴

See footnote #3
for explanations of numbered components

³ Numbered rain garden components are: ① **Curb Inlet** – The inlet allows water to flow into the rain garden as it flows down the curb toward the catch basin; ② **Curb Outlet** – Large rain gardens also have an outlet. If the rain garden fills to capacity, water can exit through the outlet; ③ **Stone Strip** – The stone strip (gravel) allows people to step out of their cars without damaging the plants; ④ **Plants** – All rain gardens have plants and grasses which have been carefully selected to ensure they can survive on busy NYC streets; ⑤ **Soil** – The soil is graded so that water ponds in the center of the rain garden; ⑥ **Tree Guard** – All rain gardens have tree guards around them that protect the plants and keep people and dogs from walking inside of it; and ⑦ **Tree** – DEP plants trees in rain gardens as often as possible. Trees benefit neighborhoods by lowering temperatures in hot summer months, improving air quality, and providing habitat for birds and butterflies. (<https://www1.nyc.gov/html/dep/html/stormwater/rain-gardens.shtml>, accessed April 15, 2019)

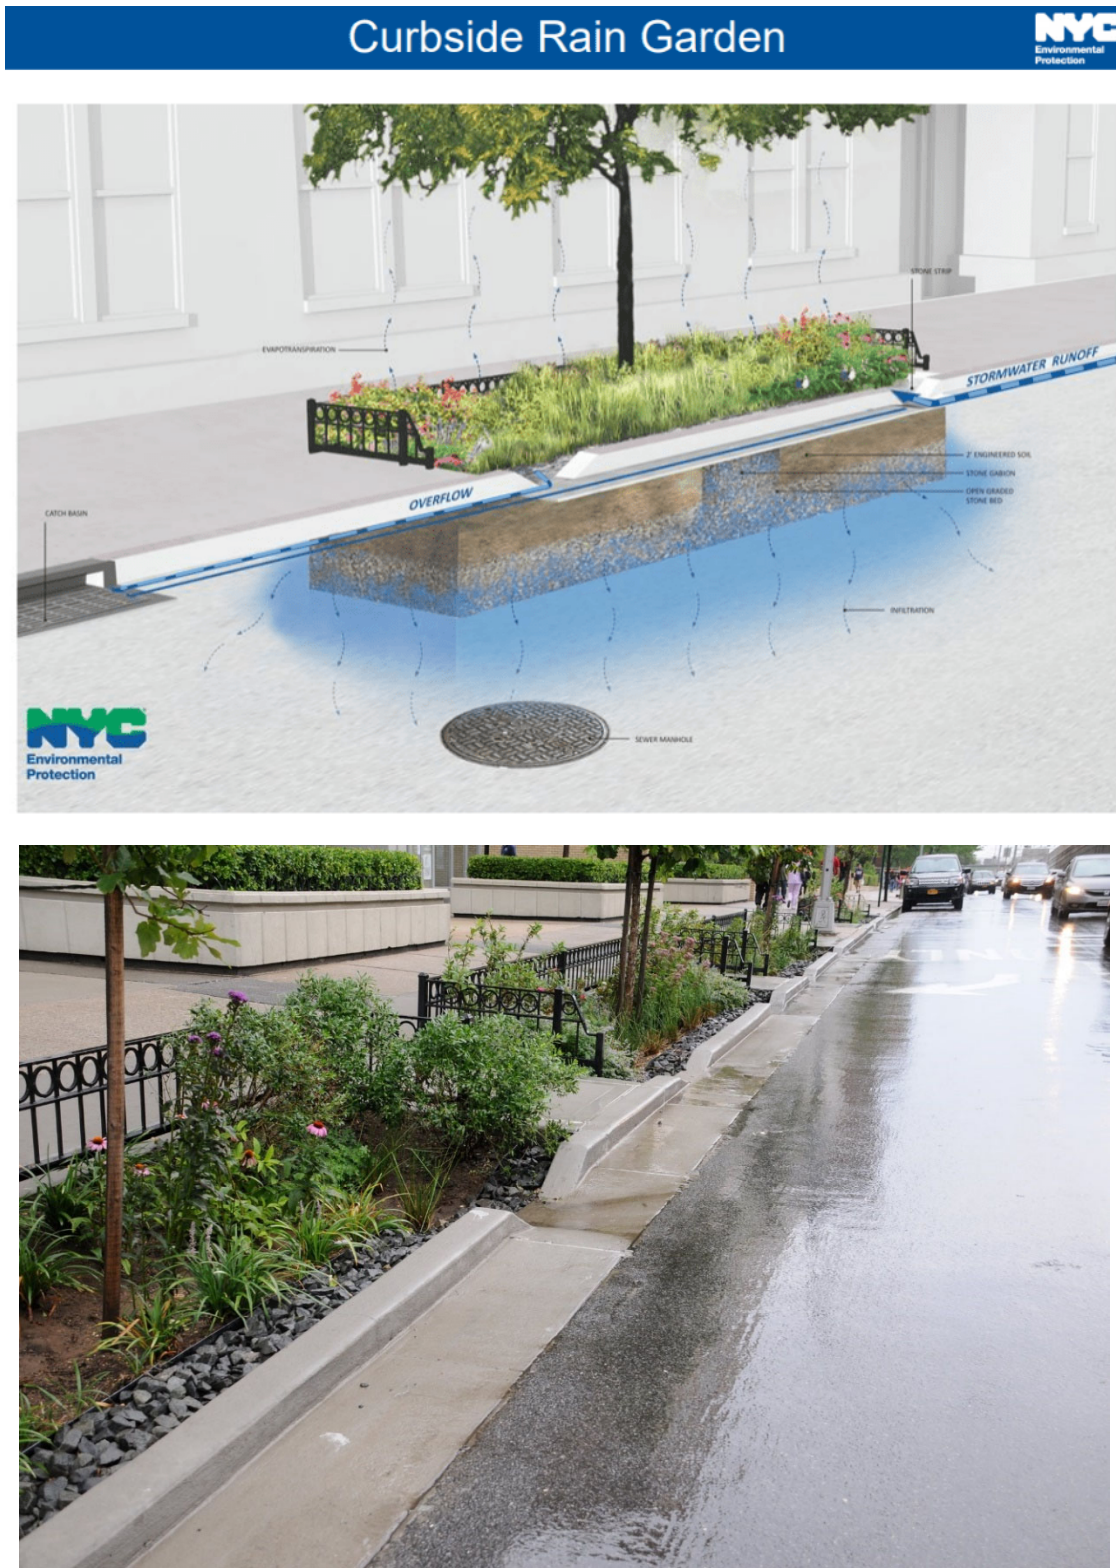
A rendering of how NYC curbside rain gardens are constructed and function, and a photograph of rain gardens in Rego Park (Queens) posted on the Internet are shown below.

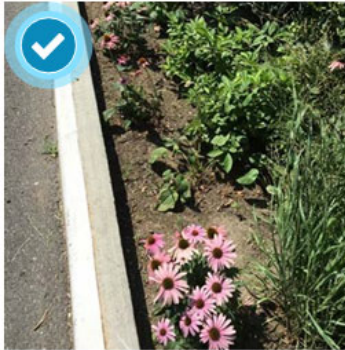
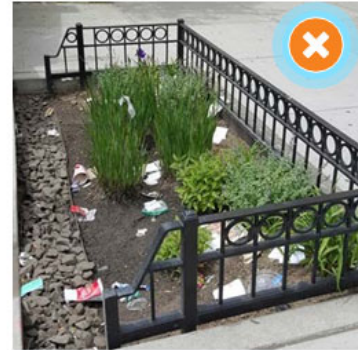
Litter and Debris. One of the biggest challenges of maintaining rain gardens is keeping up with the litter that washes in with stormwater, is dropped by pedestrians, or is blown in by the wind. Litter may be worse after large gatherings, weekends and holidays, or in highly trafficked areas. Litter instantly detracts from the appearance of a rain garden and can affect how the community regards the site. Litter must be cleaned up frequently, as well as any other debris (for example large amounts of leaves, dead plants, sticks, or any dumped material).

(Left) A cleaned curbline and well-tended plant bed. (Right) Trash, sediment, displaced stones, and weeds create an unsightly appearance.

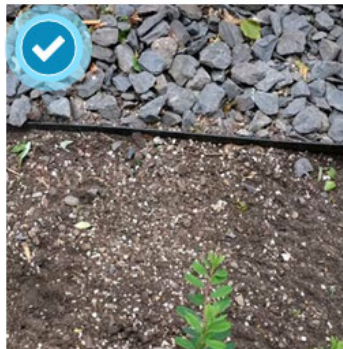
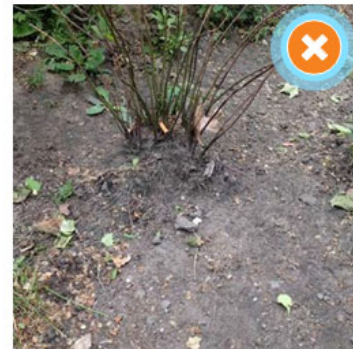
Soil Health and Permeability. Soil needs to be permeable to allow water to infiltrate. But, over the lifetime of the system, fine particles tend to build up in the soil layer and clog its pores, preventing infiltration. Regularly removing sediment and debris from the planting bed can help prevent clogging.

(Left) A loose, well-aerated soil surface. (Right) Compacted soil at base of a shrub.

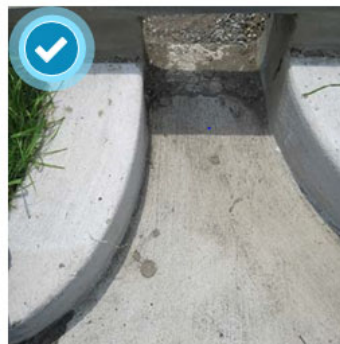
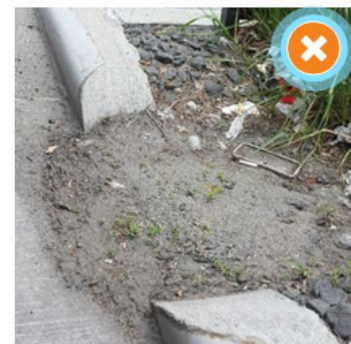
Flow Paths. In order to be managed, stormwater must be able to get into the rain garden. It must also be able to get out in a controlled manner during larger storms. Since the flow of stormwater is concentrated at the inflow points, trash, sediment, and other debris carried by stormwater often collect there. Large quantities of debris can alter the flow of water, creating pools of water in the gutter or erosion in the planting bed. In severe cases, debris clogging the inlet can cause stormwater to completely bypass the system. Removing trash and debris from these areas on a weekly basis (or more often if possible) helps keep flow paths clear.

(Left) A clean inlet opening for water entering a rain garden. (Right) An inlet to a rain garden that is partially obstructed with sediment and debris.

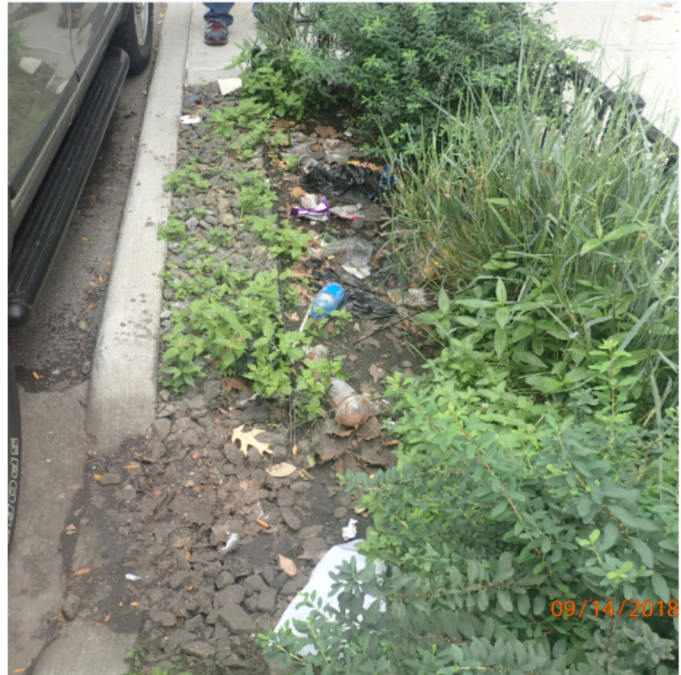
Example - DEP Failed to Maintain a Rain Garden with Multiple Deficiencies

As an example of a DEP rain garden that was inadequately maintained, during our inspection on September 14, 2018, we noted accumulations of trash, litter, leaves and weeds in the rain garden located at 63 Mother Gaston Blvd & Hull Street in Brooklyn (*Site ID# 0266a*; photo at right). We also noted that the curb at this location was sinking. When we reviewed the relevant DEP-BWSO maintenance logs, we noted that no maintenance tasks had been performed in this rain garden in the three-week period coinciding with our inspection (the weeks preceding, including, and following our inspection). When we questioned that lack of maintenance, the Brooklyn G2 informed us that the G2s decide where the field staff should concentrate their efforts based on priorities. However, that practice is inconsistent with the weekly or twice-weekly maintenance schedule specified in the Manual.

Field crews work in each rain garden *once or twice a week* to remove trash. During each visit the crew may also pull weeds, remove sediment, water plants and take note of any damage done to the rain gardens. During these visits crews also informally assess the condition of plants and structural parts of the system and document any special needs or action items. [Emphasis added.]

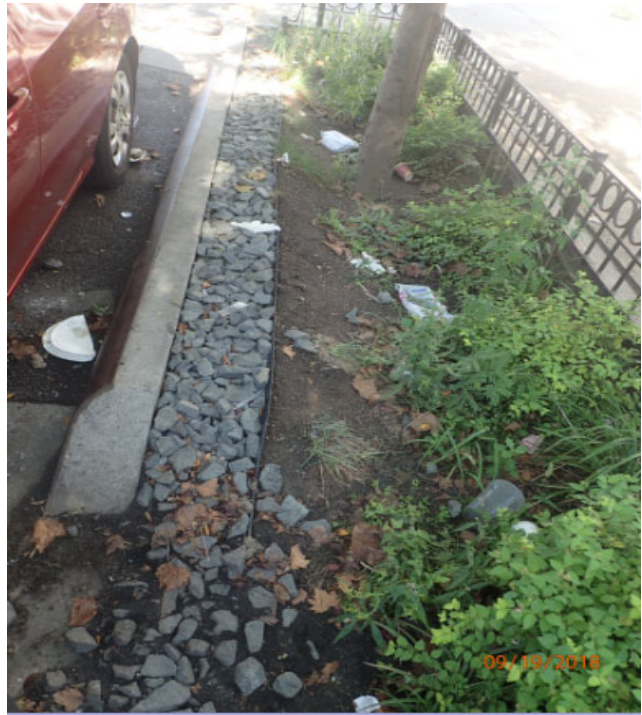
Example - DEP Failed to Address Multiple Deficiencies in a Second Rain Garden

In another example, during our inspection on September 19, 2018, in the rain garden located at 34 4th Avenue and Dean Street in Brooklyn (Site ID# B-6a; photo at right), we noted conditions of trash, litter, weeds, sparse planting, poor soil health and permeability, and the flow path partially filled with sediment. DEP's maintenance logs for this rain garden indicated that trash was removed from it in the weeks preceding, during, and after our inspection. According to the maintenance logs, weeds were also removed the week after our inspection. No other notations were present on any of the maintenance logs for the three-week period we reviewed. Based on our inspection, and the requirements specified in the Manual, the need for soil replenishment and planting should have been recorded on the maintenance logs, but neither was. BWSO does not use photographs to document rain garden conditions during its routine maintenance visits;¹⁶ therefore, we cannot comment on the actual conditions of this rain garden during the week before and the week after our inspections.

According to the Manual, plants are important to how the rain garden's system works—in addition to how it looks and how it is perceived by the community. Sparse plantings allow more trash to blow into the rain gardens, and weedy plants that are not removed can spread seeds and unwanted vegetation to other sites, such as parks and private property. Additionally, sediment that is allowed to accumulate can damage plants by burying the stems and coating the leaves and can also clog the gravel strip and soil bed, leading to less infiltration of storm water, while sediment-laden rain gardens may also be perceived by the public as unkempt.

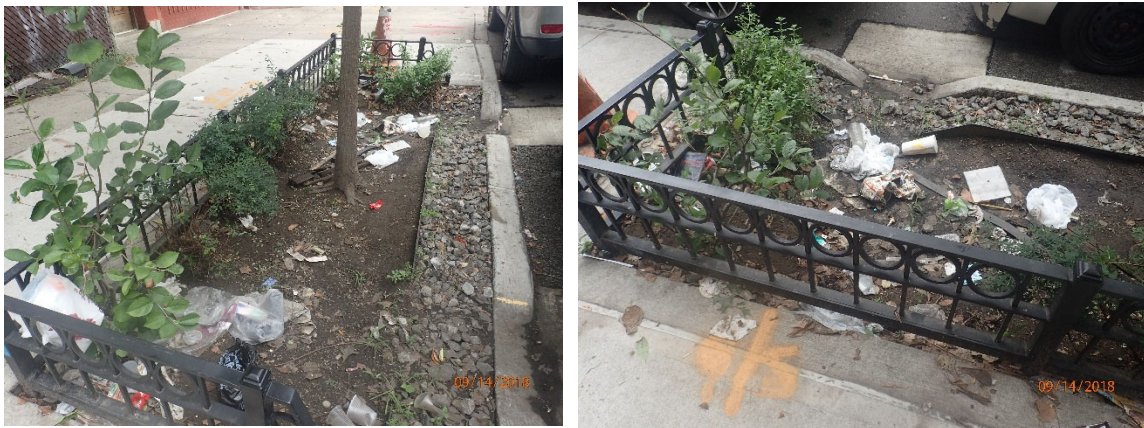
Rain Garden site # 0261d at 243 Hull Street in Brooklyn.

However, during our inspections on September 14, 2018, we noted maintenance needs at all 10 locations, for work such as trash or sediment removal, gravel cleaning and/or replenishment, and/or soil replenishment.²⁰ For example, on September 14, 2018, we noted that rain garden site # 0261d located at 243 Hull Street, Brooklyn contained accumulated litter, sparse plant coverage, a gravel strip in need of cleaning, and a soil bed that needed replenishment and raking (photos below).

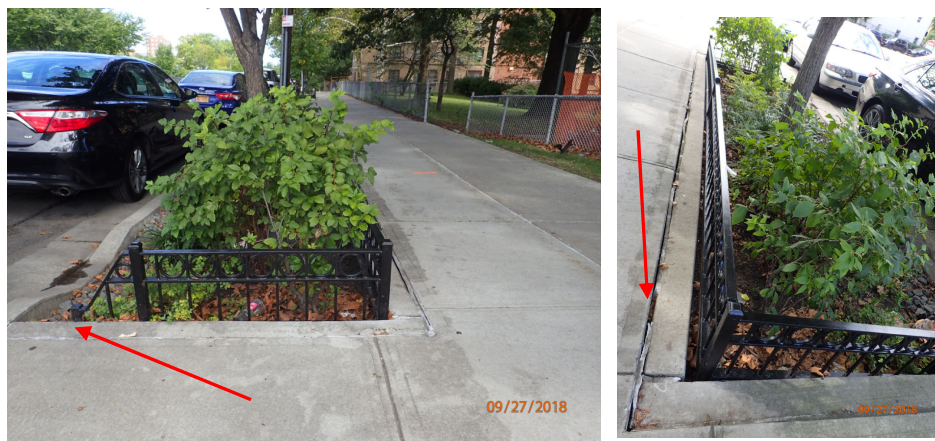
- We found 8 rain gardens with damaged or sinking tree guard rails, 6 with curbs that were damaged and/or sinking, and 1 had both issues at the time of our inspections—a total of 15 sites with those conditions, none of which were recorded in the DEP's maintenance logs. For example, on September 27, 2018, at rain garden site # B-11 on Shieffelin Avenue, Bronx, we

noted that the perimeter curb and the tree guard rails were sinking (photos below). None of these conditions were noted in the BWSO maintenance logs.

Sinking Tree Guard Rails and Perimeter Curb at Rain Garden Site B-11, 1930 Shieffelin Avenue, between E225 St. & E226 Dr., in Bronx.

- Ensure that the metal tree guard rails and curbs surrounding the rain gardens that were found either damaged or sinking at the locations cited in this report have been fixed.

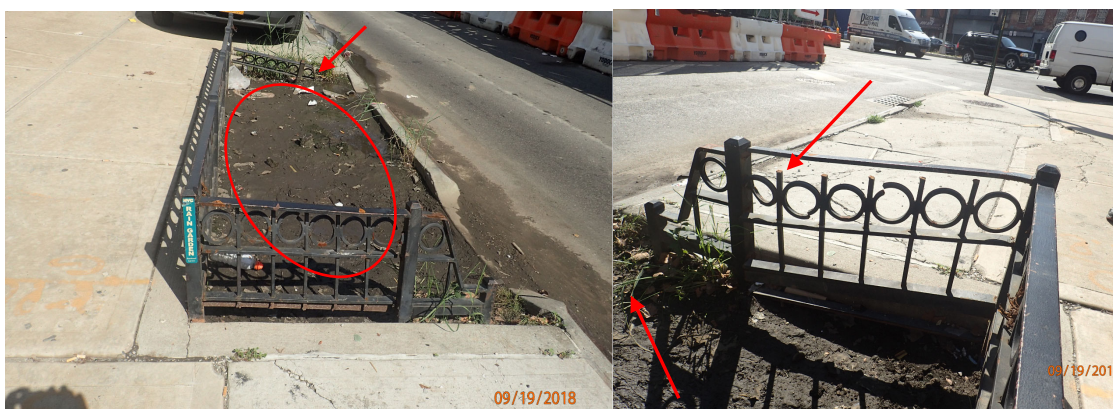
- In addition, on September 19, 2018, we observed rain garden site # B-11 on Waverly Avenue, off Atlantic Avenue, in Park Slope, Brooklyn. As shown in the photos below, this site contained no plants and no tree—all of which were missing. In addition, its tree rail guards were broken and sinking; it contained trash; and the area was muddy with sewer-like odor, an indication of prolonged ponding conditions. However, none of those conditions/details were noted in the DEP’s maintenance log. According to the maintenance log for that week, the site had been cleaned of trash two days before our visit. *The log contained no indication that any additional tasks were performed or required*, notwithstanding its decimated condition and the Manual’s instruction that maintenance “crews informally assess the condition of plants and structural parts of the system and document any special needs or action items.” In addition, the BWSO files contained no documentation, and DEP did not provide any documentation including photographs, that would support DEP’s claim (after the exit conference) that BWSO followed a standard protocol for documenting, reporting and follow-up on slow drainage or ponding conditions—each of which is an indication that a rain garden is not functioning as designed.²¹

Rain Garden site B-11 at 551 Waverly Avenue in Brooklyn.

²¹ We also revisited this rain garden on May 16, 2019 and on June 21, 2019, and found that the conditions had further deteriorated.

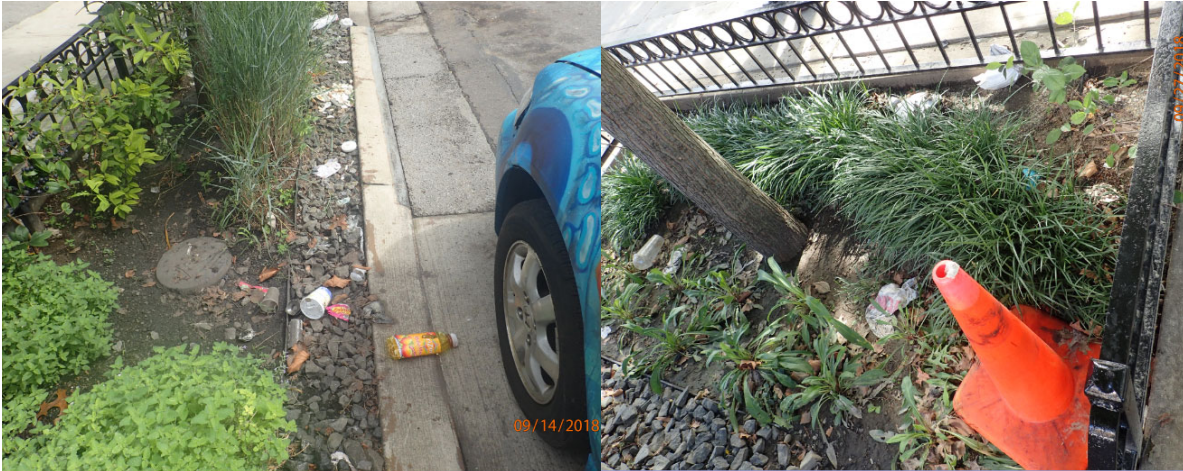
Contained Trash and Debris

221 ***Hull St.*** & Mother Gaston Blvd.,
Brooklyn (Site ID# 0261b)

1175 ***E 229 Street***, Bronx
(Site ID# B-26A)

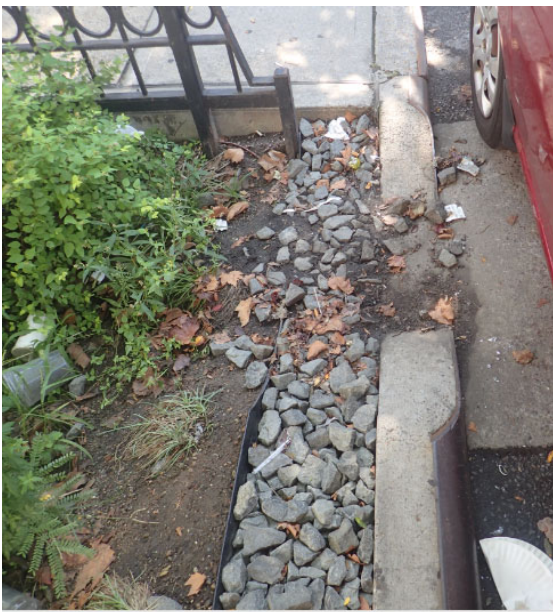
34 4th Avenue & ***Dean Street***, Brooklyn
(Site ID# B-6a)

Needed Sediment Removal and Flow Path Cleared

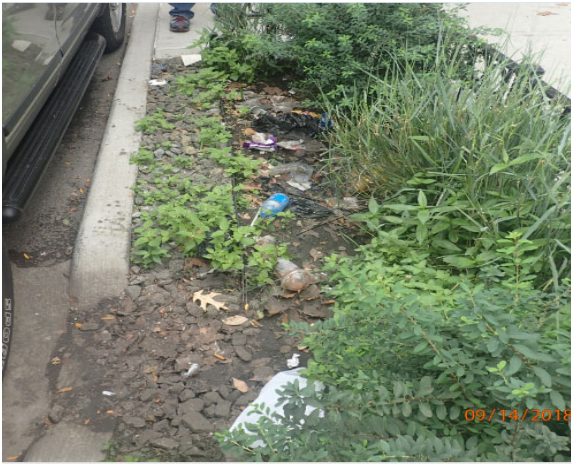
63 **Mother Gaston Blvd.** & Hull Street,
Brooklyn (Site ID# 0266a)

Needed Gravel Cleaning

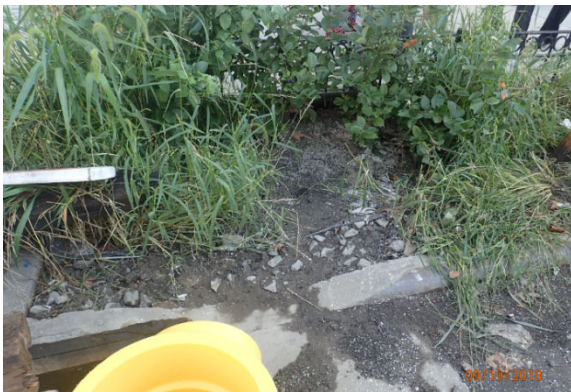
487 **Clermont Ave.** & Atlantic Ave.,
Brooklyn (Site ID# B-4)

Needed Gravel

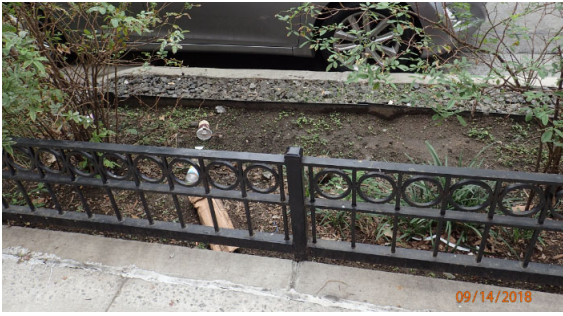
1765 Broadway & **Chauncey Street**, Brooklyn (Site ID# 0299b)

Needed Soil Replenishment and Raking

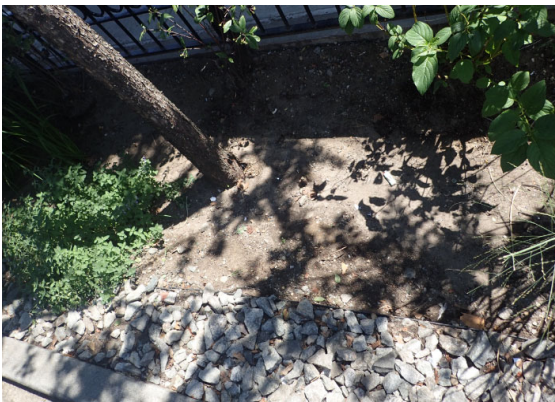
63-54 108th St. & **63rd Dr.**, Queens (Site ID# 4337a)

Needed Supplemental Planting

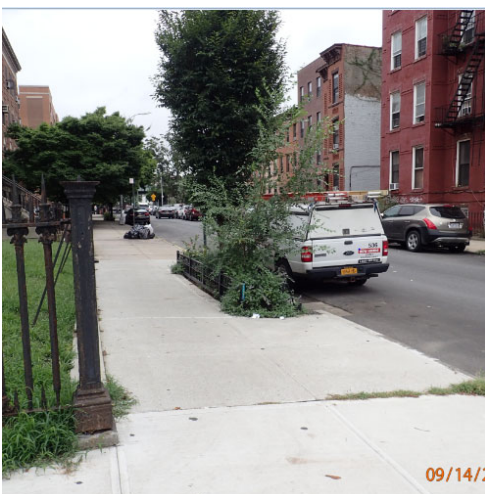
1420 Bushwick Ave., & **Moffat St.**, Brooklyn (Site ID# 0305a)

Needed Pruning
